Nondestructive Imaging and Diagnosis of Concrete Structures with Ground Penetrating Radar and Infrared Thermography

Ir Dr. Wallace Wai-Lok LAI^{1,2} and Dr. Janet Fung-Chu SHAM¹

Corrosion diagnosis of ground penetrating radar in Hong Kong-Macau ferry pier

Diagnosis of Reinforced Concrete Structures by Ground Penetrating Radar Survey- Case Study

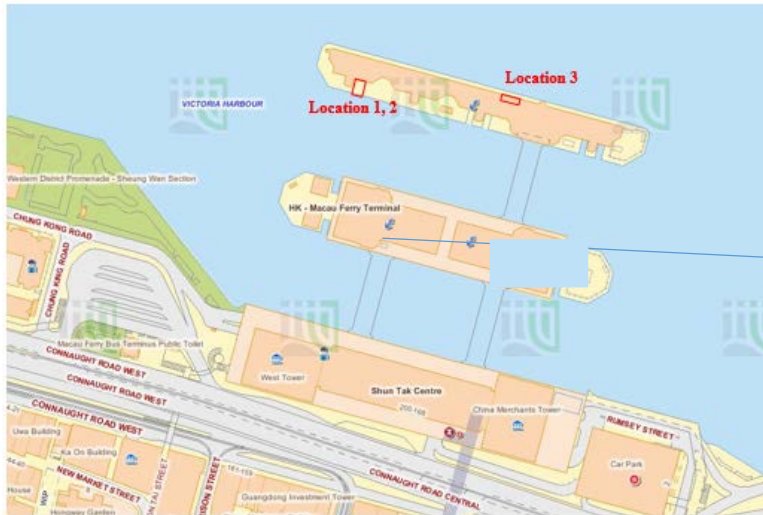
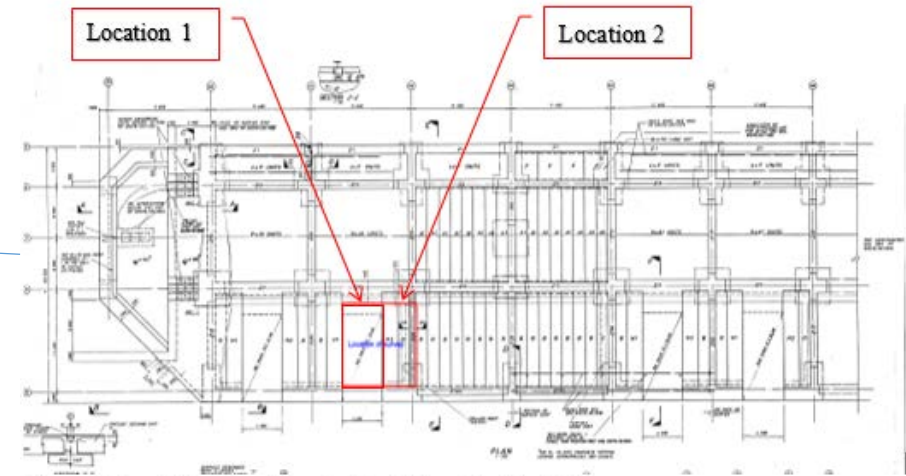
Figure 2: Record drawing of Location 1 and 2 provided by CEDD

Surveyed area: 9m x 4m

Surveyed area: 8m x 1.5m x 0.35m depth

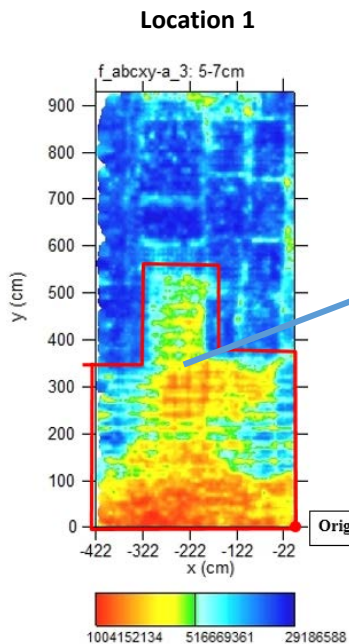
Findings: Signatures of abnormal GPR signals (C-scan slices)

Abnormal Signals

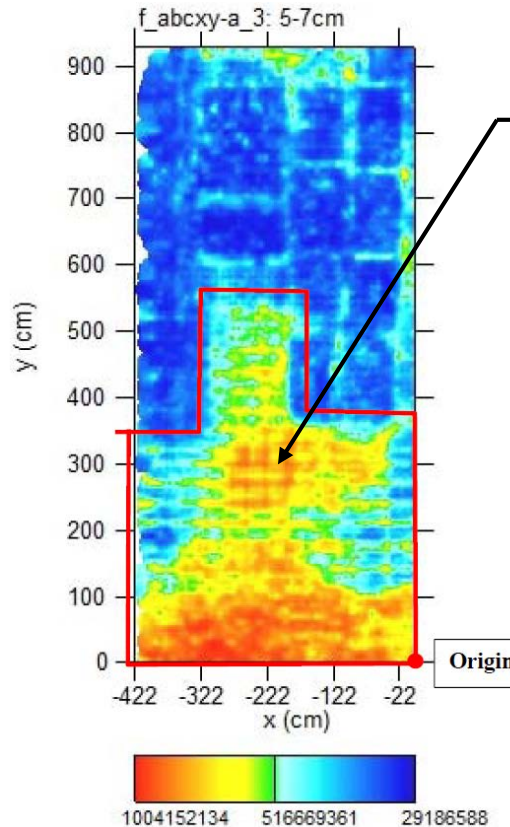
Findings: Open-up by hacking off surface concrete

> Reinforced concrete slab

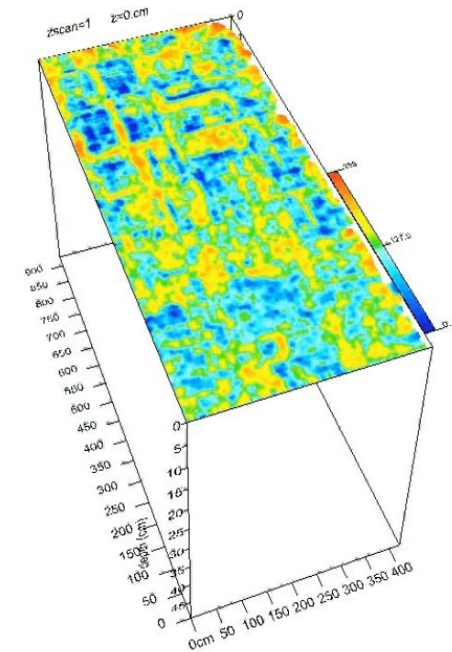
Abnormal high
signal amplitude

The delamination
confirmed by open-up

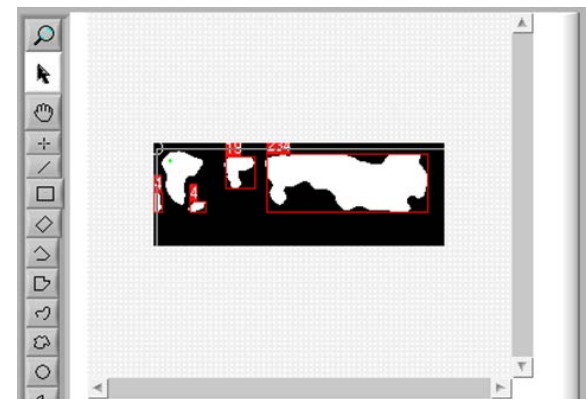
Suspected water seepage areas and their estimated size are indicated automatically in the IR image
