**Report of the Task Force on
Investigation of Excessive
Lead Content in Drinking Water**

October 2015

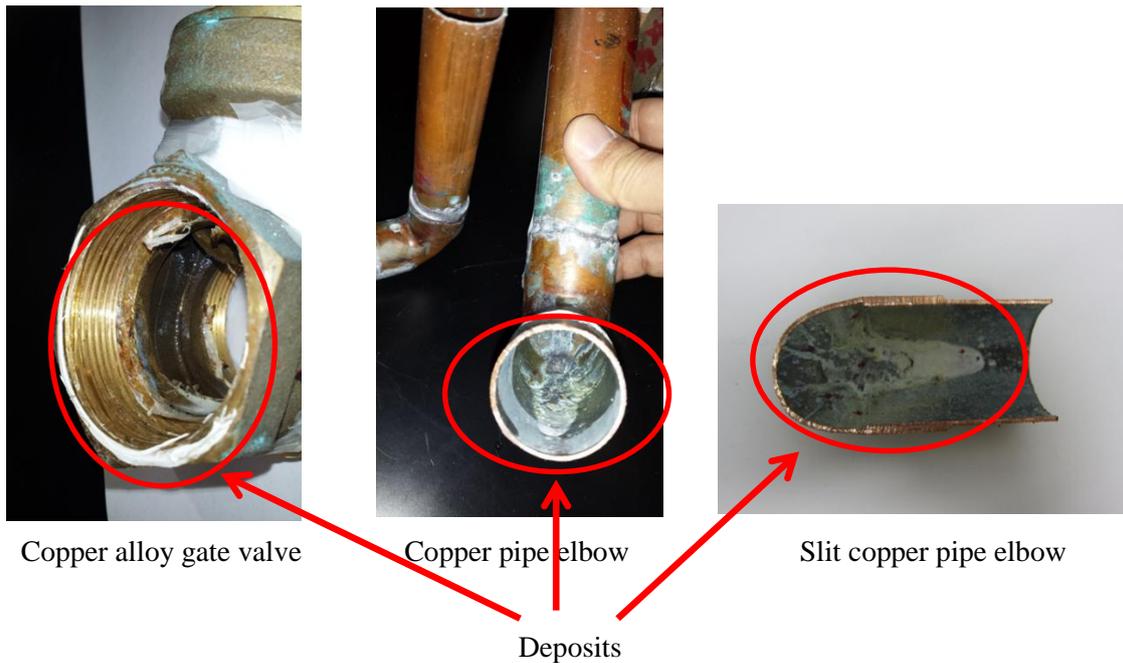
Figure 2.5 Deposits in copper alloy valve and copper pipe elbows

2.5.3 On examination, deposits of various amounts were found inside the components of pipes and fittings in the branch pipes as shown in the photos in **Figure 2.5**. It was believed that there were lead containing compounds which might release lead into the drinking water.

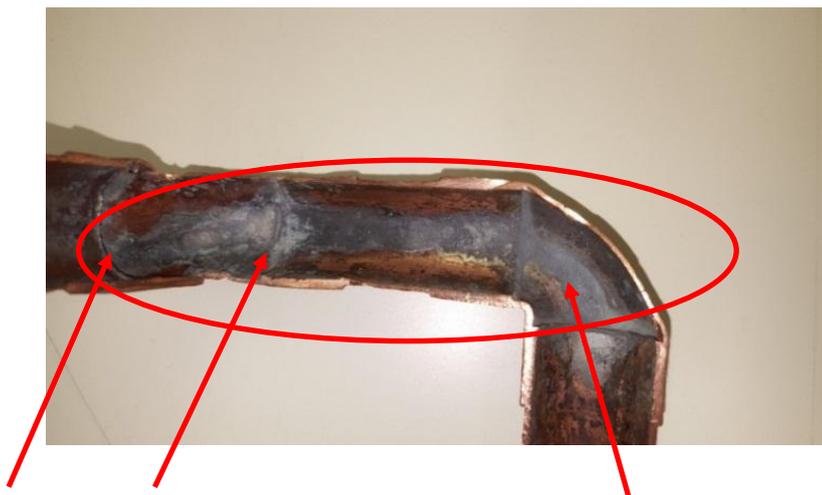
Leaded solder joints

2.5.10 Similarly, solder joints still leached lead after cleansing the deposits although the leached amounts had been reduced. The elemental analysis showed that the lead contents of the solder in most of the joints tested were between 33% and 41% which were well above the limit for lead-free solder stipulated in the BS¹² of 0.07%. The Task Force therefore considered that lead leaching also occurred in the solder joints. A photo of leaded solder joint is shown in **Figure 2.6** below.

Solder materials seeped into the pipe due to poor workmanship by overheating for an extended period of time and/or applying excessive solder.

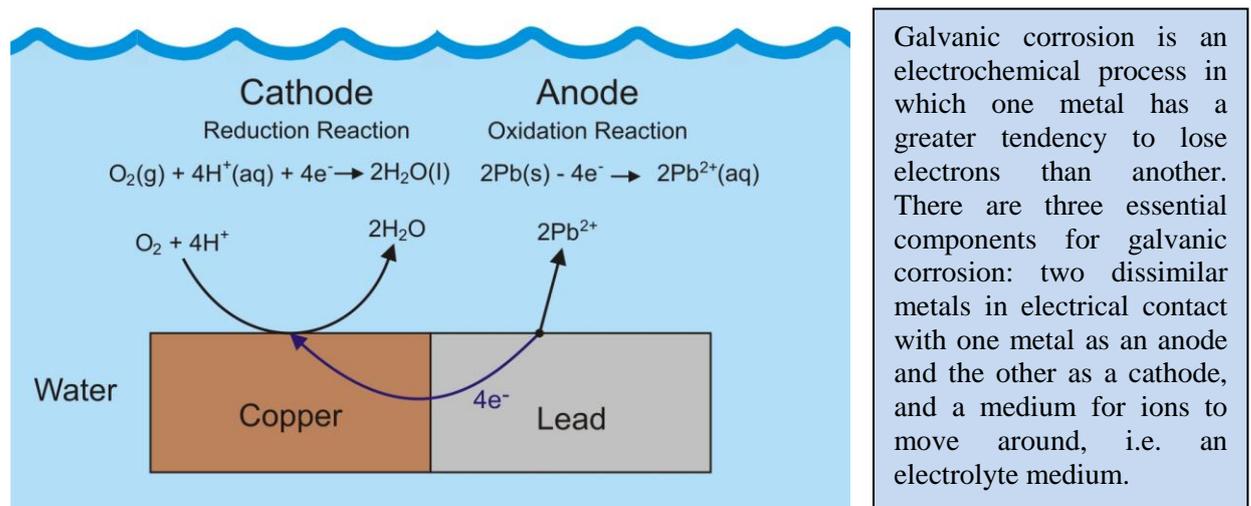
Figure 2.7 Schematic diagram illustrating lead leaching by galvanic corrosion

2.8.1 The mechanism for lead leaching from copper alloy fittings and leaded solder joints in contact with water is the formation of a corrosion cell between the lead and the copper resulting in galvanic corrosion. Under this setting, copper acts as the cathode metal, lead acts as the anode metal and water is the electrolyte medium. As lead has a greater tendency to lose electrons to form positive ions than does copper, lead ions leach into water as a result of galvanic corrosion and the process is shown in **Figure 2.7**.

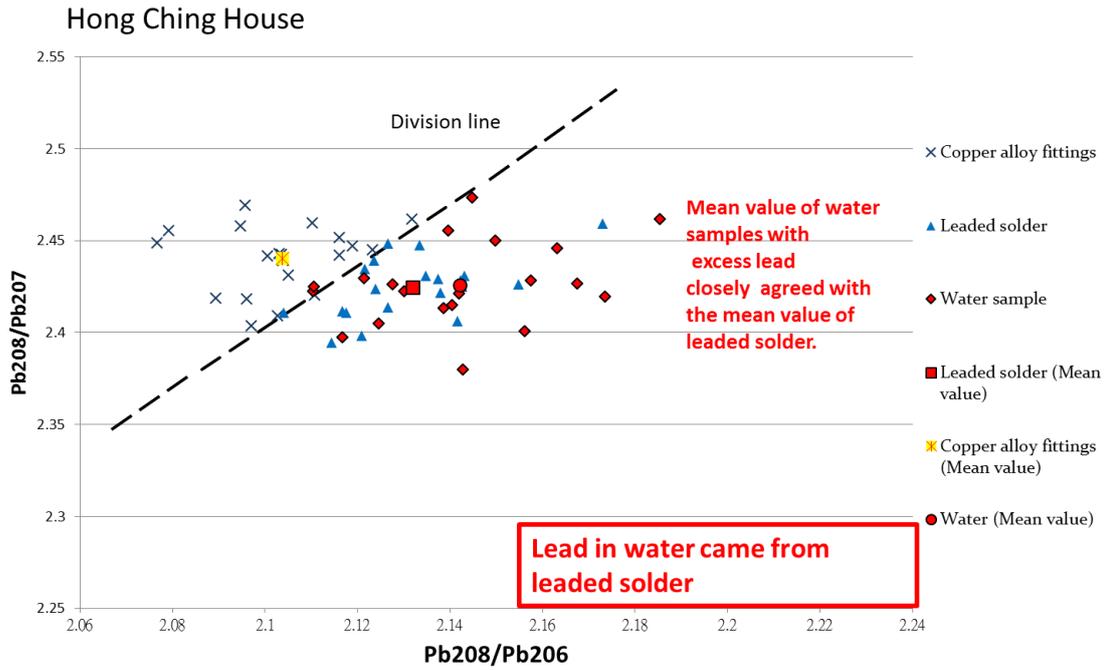
Figure 2.9 Isotopic analysis for the water supply chain in Hong Ching House of KCE

- 2.9.6 Results of the isotopic analysis for the three water supply chains are shown in **Figures 2.9-2.11**. LDA of the lead isotopic ratios of the copper alloy valves and the leaded solder joints showed that they were two separate clusters at 95% confidence level and were significantly different from each other in all three water supply chains.
- 2.9.7 Further analysis of the isotopic ratios of the lead in the water samples showed that their mean values closely agreed with those of the leaded solder joints at 95% confidence level. It was therefore deduced that the lead in drinking water mainly came from the leaded solder joints.

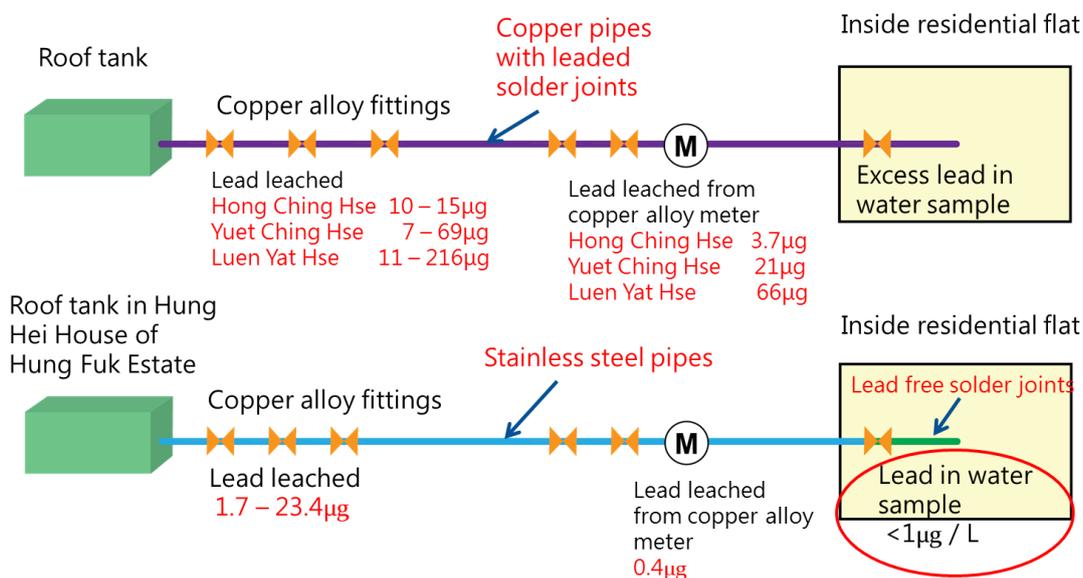
Figure 2.12 Comparison of the control water supply chain in HFE with that of the three water supply chains in KCE and KLE2

2.11.4 Therefore, by comparing the control water supply chain in HFE (without leaded solder joints) with the three water supply chains in KCE and KLE2 (with leaded solder joints) as shown in **Figure 2.12**, it could be confirmed that leaded solder joints should be the cause of excess lead in drinking water and even

though the copper alloy fittings leached lead, they would not result in excess lead contents in drinking water.

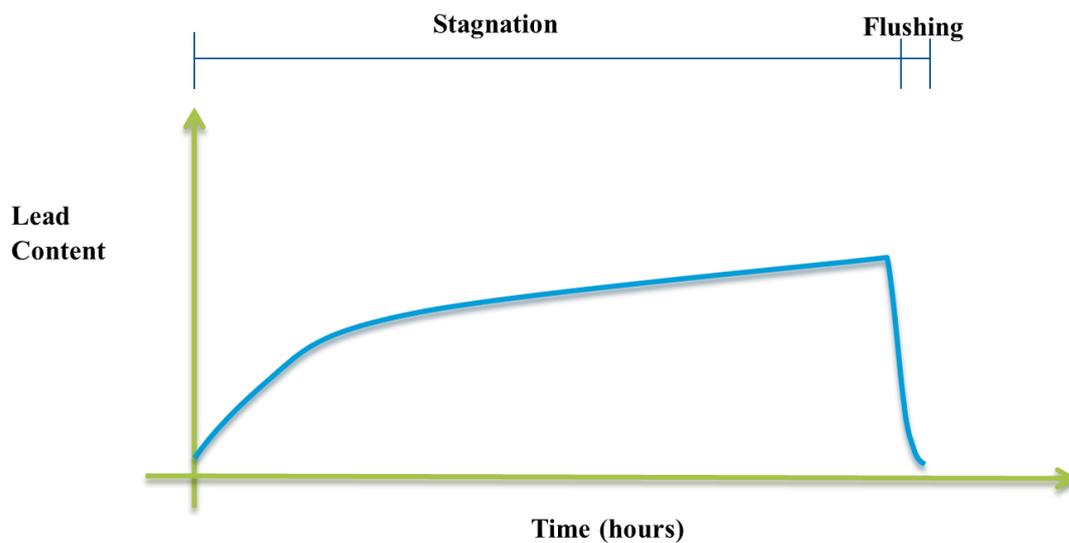
Figure 2.13 Generalised results of stagnation and flushing tests

2.12.4 The results of the stagnation and flushing tests conducted in the three vacant flats and one management office revealed that the lead contents in water would increase with its stagnation time in the water supply chain if there was lead leaching from its components. In addition, the test results also indicated that the lead contents in the stagnated water could be reduced substantially after flushing for about two minutes. The test results are illustrated in **Figure 2.13** below and a combined graph is presented in **Annex 2.9**.
