## TREE EMERGENCY INSPECTION REPORT

TREE NO	T17	REF NO	005
INSPECTION NO	E03	INSPECTION DATE	23 Jan 2010 24 Jan 2010
OWNER	Maryknoll Convent School	ACTUAL LOCATION	114° 10' 43" E 22° 19' 40" N
GEOGRAPHICAL LOCATION	Northwest Corner of the Building of Maryknoll Convent School, No. 130 Boundary Street, Kowloon.	WEATHER CONDITION	Fine

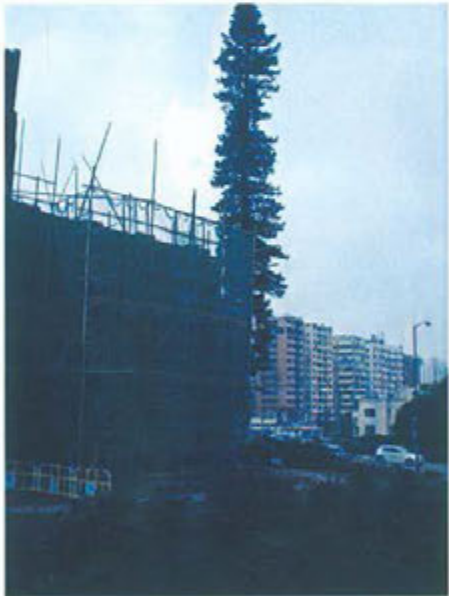
<p>Fig 1: Tree overall looking on Jan 24.</p>

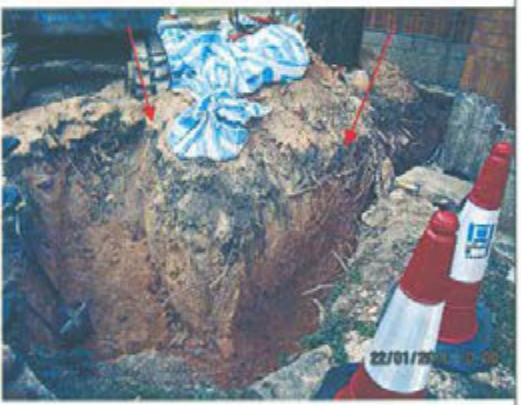
SITE	<ol style="list-style-type: none"> <li>1. Two deep trenches 400 mm (wide) x 800 mm (deep) were dug on two sides of the tree by the Construction Contractor.</li> <li>2. The distances between the trenches and the base of the main trunk of the tree were less than 1 meter.</li> <li>3. Two major side roots 100 mm (dia) was exposed and badly damaged, much of small roots was find by cutting.</li> <li>4. QA was identifying the fungicide to protect the damage root surface asap.</li> <li>5. The Construction Contractor backfill the soil on Jan 24 noon.</li> </ol>
GROUND COVER	The ground vegetation cover surrounding the tree was completely ruined by machinery movement. The soil was also compacted by the movement of the machinery and the weight of the machinery plus the concrete mixed carried.

ORIGIN OF RISK	Due to the Construction Contractor digging the trench very closed to trunk, and damage tree roots system.		
HAZARD RATING	Hazard Rating = Failure Potential + Size of Part + Target Rating $\underline{\quad 11 \quad} = \underline{\quad 3 \quad} + \underline{\quad 4 \quad} + \underline{\quad 4 \quad}$	Failure potential: 1 = low; 2 = medium; 3 = high; 4 = severe Size of part: 1 = <50mm; 2 = 51 – 100mm; 3 = 101-150mm; 4 = >150mm Target rating: 1 = occasional use; 2 = intermittent use; 3 = frequent use; 4 = constant use	Hazard Location: <u>Roots</u>
RISK RATIO	<b>Due to 50% surface root system was damage, surface soil was compact by heavy machine, tree dead ratio more than 50%.</b>

<p>Fig 2: Two trenches were digging up on Jan 23 that closed to tree trunk.</p>
-------------------------	---	--

<p>HAZARD ABATEMENT</p>	<p>1. Restrict Area : 1                  2. Cable : 0                  3. Removal : 0                  4. Replanting : 0                  5. Prune : 0                  6. Supporting : 1                  7. Effect on adjacent tree : 0                  8. Inspect further : 0                  9. Notification : 0</p> <p>This kind of work defied the purposes of protecting the respective tree.</p>	<p>CARRY OUT THE WORK :</p> <p>0=NONE;                  1=IMMEDIATELY;                  2=STAY BEHIND;                  3=UNNECESSARY;                  4=OTHER_____</p>
<p>COMMENT</p>	<p>1. <b>The tree unstable now, tree supporting system immediate needs.</b>                  2. <b>Inspection by weekly.</b></p>
