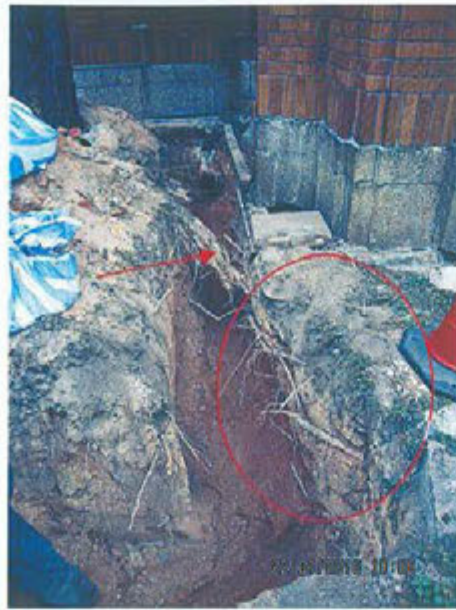
Fig 3: The root system was damage, record on Jan 23.

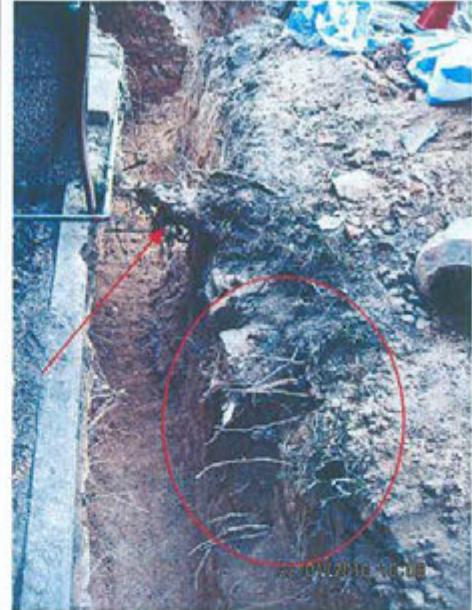
Fig 4: The root system was damage, record on Jan 23.

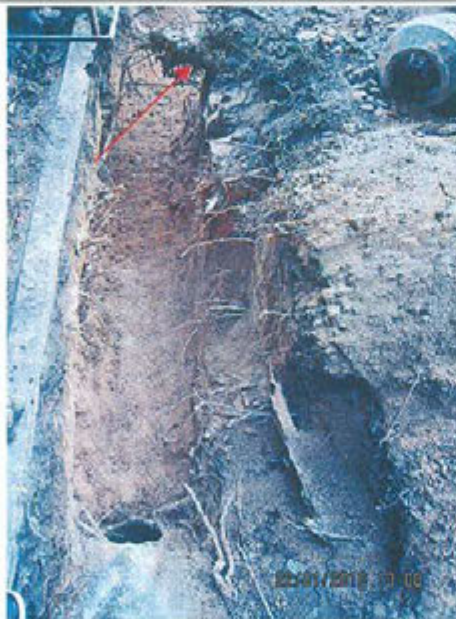
Fig 5: The root system was damage, record on Jan 23.

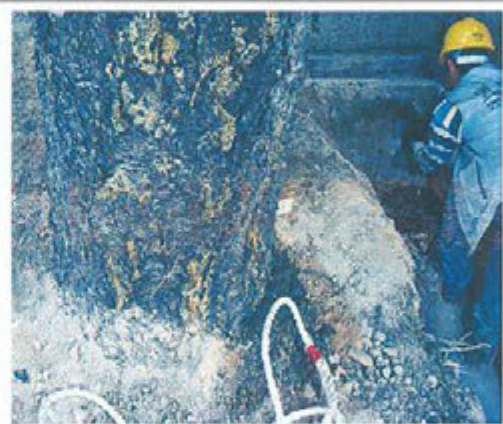
Fig 6: The truck and trench, record on Jan 23.

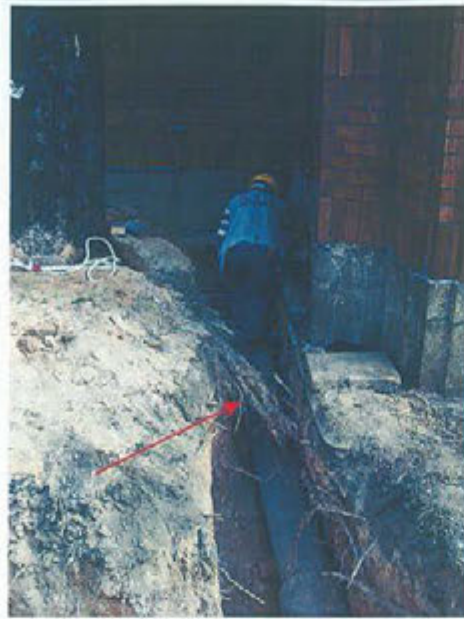
Fig 7: The truck and trench, record on Jan 23.

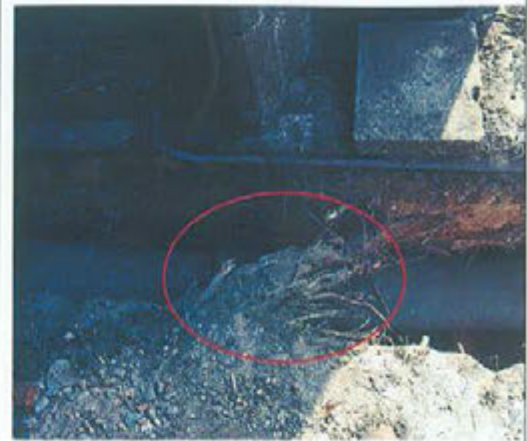
Fig 8: The truck and trench, record on Jan 23.

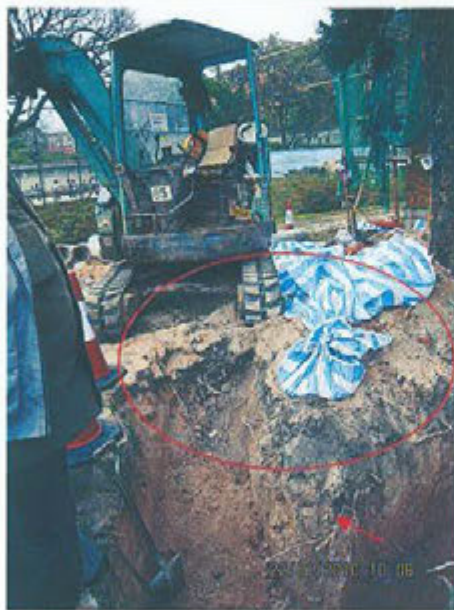
Fig 9. Heavy duty machine on surface, record on Jan 23.

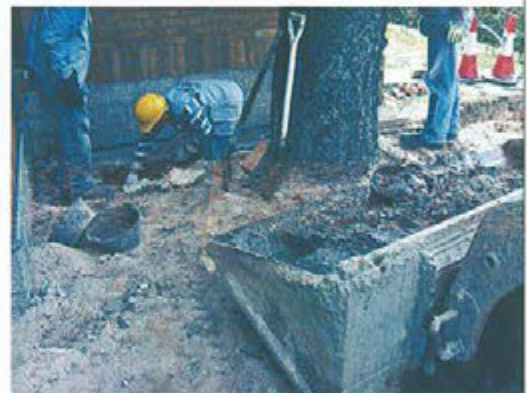
Fig 10. Bobcat and concrete near trunk, record on Jan 23.
