RESISTANCES OF A STAINLESS STEEL-CLAD REINFORCING BAR TO CHLORIDE-INDUCED CORROSION IN CONCRETE

Gerardo G. Clemeña, Ph.D.

Virginia Transportation Research Council

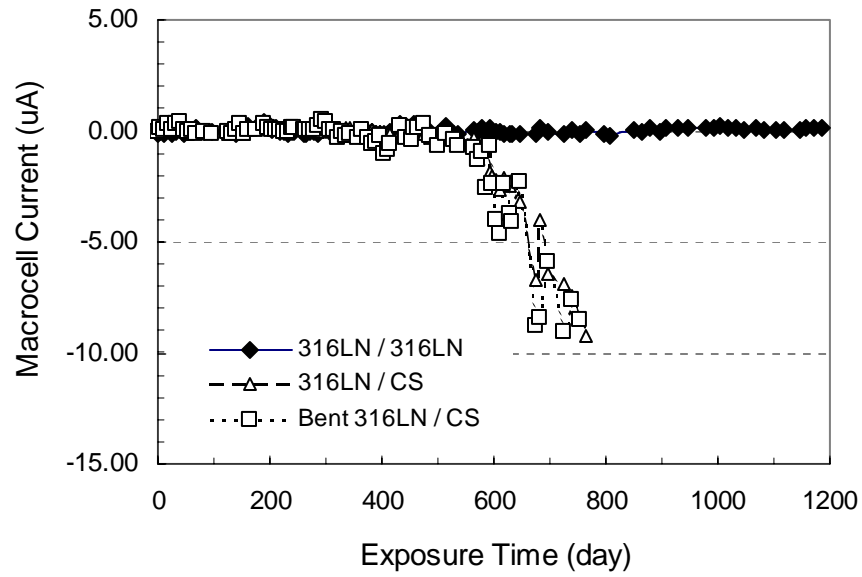
Figure 3. Macrocell current of test concrete blocks with 316LN stainless steel bars in various bar combinations described in Table 1.

Figure 3 shows the macrocell currents for the three subsets of concrete blocks containing 316LN bars, which are known for their excellent corrosion resistance. For those with 316LN in the top and bottom portions (i.e., blocks 316LN/316LN), their weekly macrocell currents even after 1,299 days (or 186 weekly cycles) of salt exposure were still practically indiscernible (even at an expanded scale of 40x) or insignificant, averaging only 0.0 μA at a standard deviation of $\pm 0.2 \mu\text{A}$ during that period, which indicates that the 316LN bars were still passive (Table 3). In addition, Figure 3 shows that after approximately 400 days, the concrete blocks with a combination of 316LN bars at the top and carbon steel bars at the bottom (i.e., the 316LN/CS and the Bent 316LN/CS blocks) began to exhibit negative macrocell currents. This indicated that sufficient chloride ions had reached the depth of the carbon steel bars, so that they became more anodic than the top 316 LN bars and were, therefore, corroding. As indicated in Table 3, the macrocell currents for these two subsets of blocks reached as much as - 9.0 to - 9.2 μA before measurements for these blocks were terminated at approximately 752 days due to cracking of some of the blocks at around the bottom carbon steel bars (see Figure 4).

The graphs for the new clad bars, which are shown in Figures 5, are essentially similar to those shown in Figure 3 for the 316LN bars. All of these graphs share two common characteristics. First, the lack of any significant macrocell current in the concrete blocks containing either 316LN or clad bars in both mats, even after 1,299 days of the salt exposure regime. This implies that the clad bars had, so far, exhibited the same good resistance to attack by chloride ions in concrete, as the solid 316LN bars had. Secondly, the appearances of undesirable negative macrocell currents (after 350 to 450 days) in the blocks wherein carbon steel bars were used in the bottom mat.

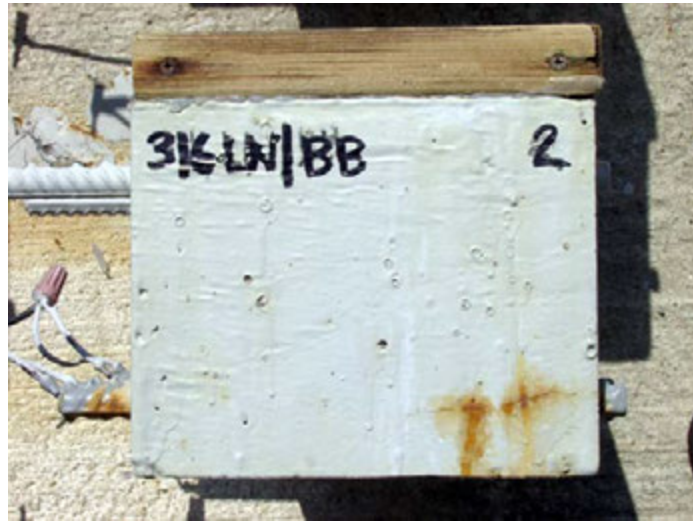
Figure 4. Side view of a concrete block with 316LN bars at the top and carbon steel bars at the bottom.

As additional (to the symptoms illustrated in Figure 4) proof that such negative macrocell currents mean that the bottom carbon steel bars were already corroding before the apparently more corrosion-resistant bars at the top were, four sets of those concrete blocks that showed negative currents were flipped upside down at approximately 270 days and the potentials and corrosion rates of the bottom carbon steel bars were measured – the latter using the linear polarization method, with the aid of a guard-ring electrode assembly, and assuming that the

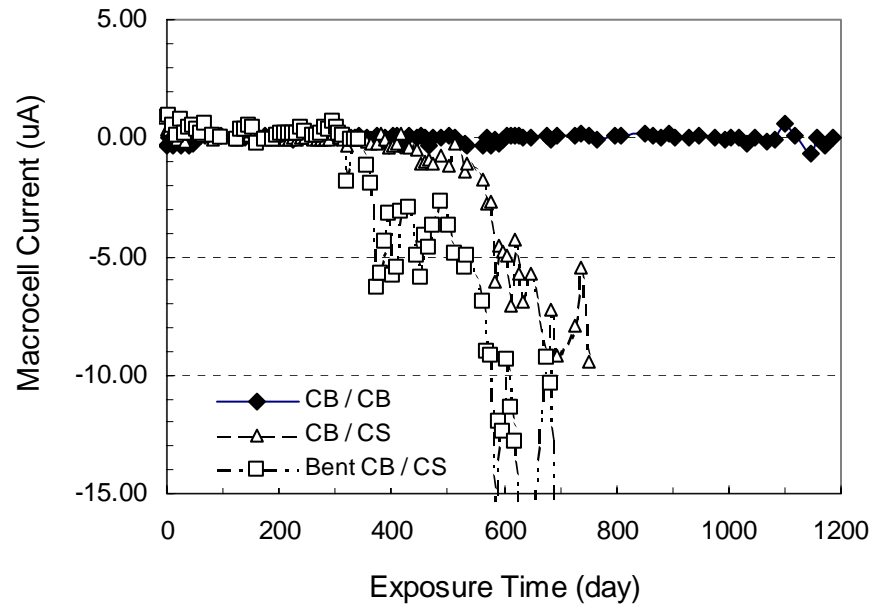
Figure 5. Macrocell current of test concrete blocks with 316L stainless steel-clad bars in various bar combinations.

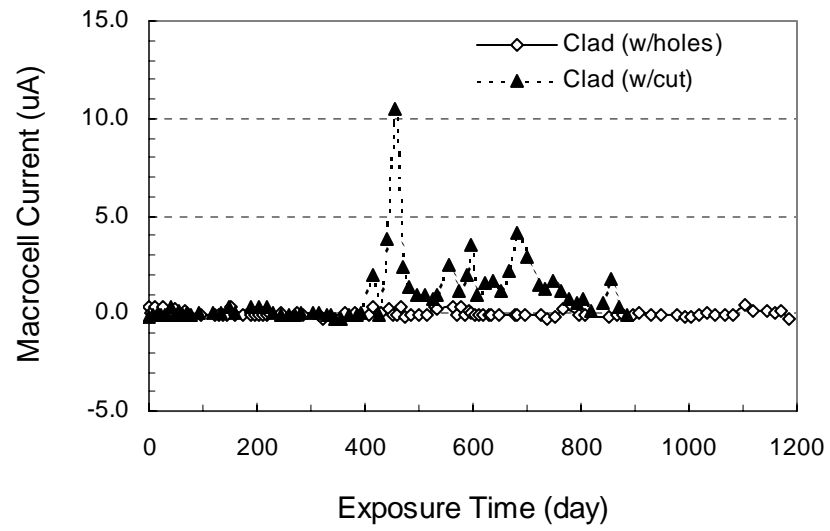
Figure 6. Macrocell currents of the concrete blocks with the clad bars with either drilled holes or a cut through the cladding.

The stainless steel clad bars with three holes drilled through the cladding had no significant macrocell current, even after 1,186 days of exposure (Figure 6). In contrast, the clad bars with a cut intentionally introduced through the cladding began to show measurable positive macrocell current at 392 days. However, the maximum macrocell current exhibited by these bars was only 10.5 μA on Day 456, which is comparatively less than the magnitudes of the currents observed on the carbon steel (Figure 2). Regardless, this likely indicates that the exposed carbon steel core underneath the cut had begun to corrode. It is worthwhile to continue observing these bars to determine whether this activity continues with time.

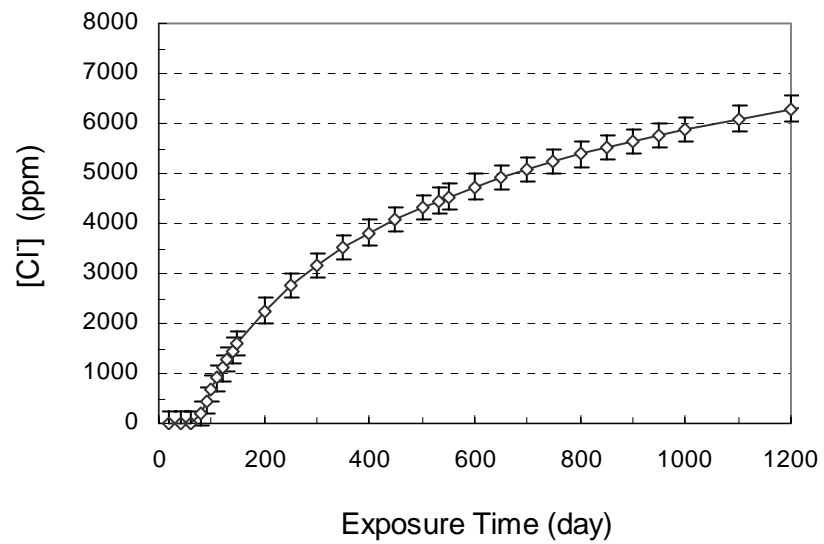
Figure 7. Estimated mean chloride concentrations in the concrete blocks, at the depth of top bars (33 mm), as a function of exposure time.

To equate the estimated time-of-corrosion of each bar to its chloride corrosion threshold, the mean chloride concentrations in the concrete blocks at different depths were determined by analysis of the ground concrete samples extracted from 16 randomly selected test concrete blocks, after several different exposure times. From the best-fit curves for these several chloride ion distributions, the mean concentration of the chloride ions in the test blocks at the depth of the top-mat bars – 33 mm – as a function of exposure time was derived (see Figure 7). This function, in turn, provided estimates of the chloride corrosion thresholds of the various bars, which are listed in Table 4.

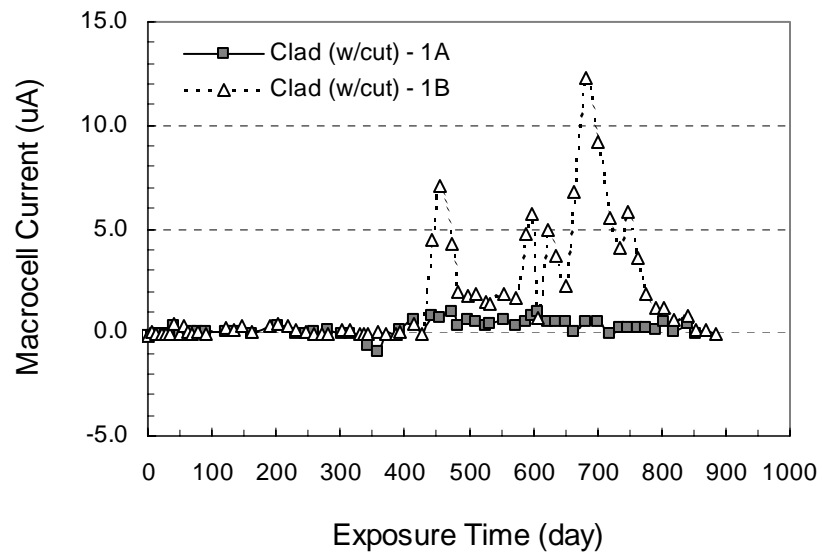
Figure 10. The macrocell currents flowing between clad bars with cuts 1A and 1B and their respective accompanying bottom clad bars.

The effect of cladding damage or defect on the corrosion resistance of stainless steel clad bars is an interesting issue. As indicated in the earlier discussion, when the defect or damage was a cut, of 25-mm (1.0-in.) long and 1-mm (0.04-in) wide, in each of the top clad bars, these bars began to show positive mean macrocell current between them top and the bottom clad bars and an abrupt shift toward electronegativity in their mean open-circuit potentials, at approximately 392 days. This signaled that corrosion was initiated on some of these clad bars with cuts at that

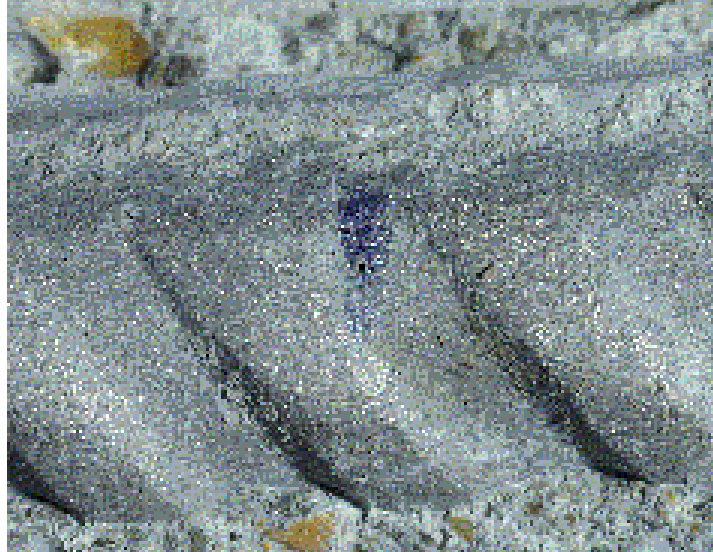
Figure 11. One of the holes (marked area in the center) drilled through the cladding of a clad bar. Notice the absence of any sign of corrosion around the hole, even though it was apparently not filled with cement paste.

In contrast, the absence of macrocell current for the entire 1,299 days of testing of the clad bars with holes drilled through the cladding (Figure 9) suggested no corrosion yet on these bars. Similar autopsy of a concrete block with two of these bars confirmed no sign of corrosion around each of the holes (Figure 11). All these results certainly pointed toward a possible influence of size of cladding defects on loss of protection for the carbon steel core, if any. The cuts introduced on some of the clad bars in this investigation were probably unrealistic. Although it is expected that the stainless steel cladding would be very resistant to damage by impact, abrasion, or penetration, it is conceivable that cladding “breaks” can occur if sections of clad bars with insufficient cladding are bent. In that case, what is the minimum of size of possible defects beyond which loss of protection for the core would be significant?
