SPECIAL PROJECT REPORT

76378  
SPR 2/96

A LABORATORY INVESTIGATION  
ON THE DEVELOPMENT OF SURFACE  
RUSTING OF STEEL REINFORCEMENT  
BARS MANUFACTURED BY  
CONVENTIONAL HOT ROLLING METHOD  
AND BY THE TEMPCORE PROCESS

May 1996  
Materials Division

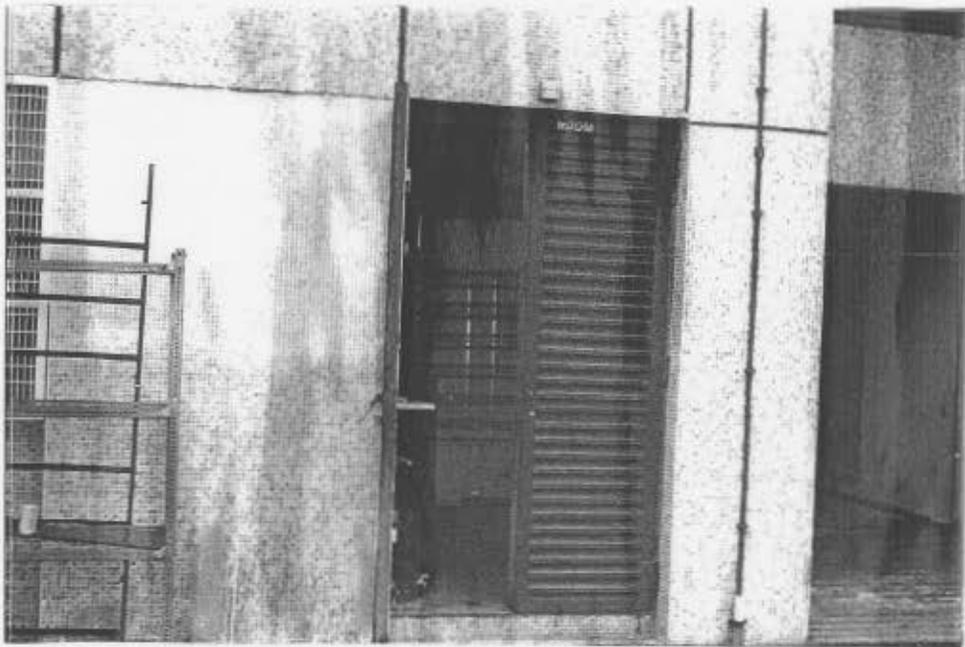
Plate 2 - Storage Room at Ground Floor Level of the Public Works Central Laboratory Building

- (a) Six bars were selected for each manufacturing method, in pairs of 12 mm, 25 mm and 40 mm diameter.
- (b) The samples were stored in a ventilated room at the ground floor level of the PWCL Building (see Plates 1 and 2), under ambient temperature and relative humidity conditions, but sheltered from direct exposure to sunlight and rain.
- (c) Photographs were taken at about monthly intervals for a period of over one year.

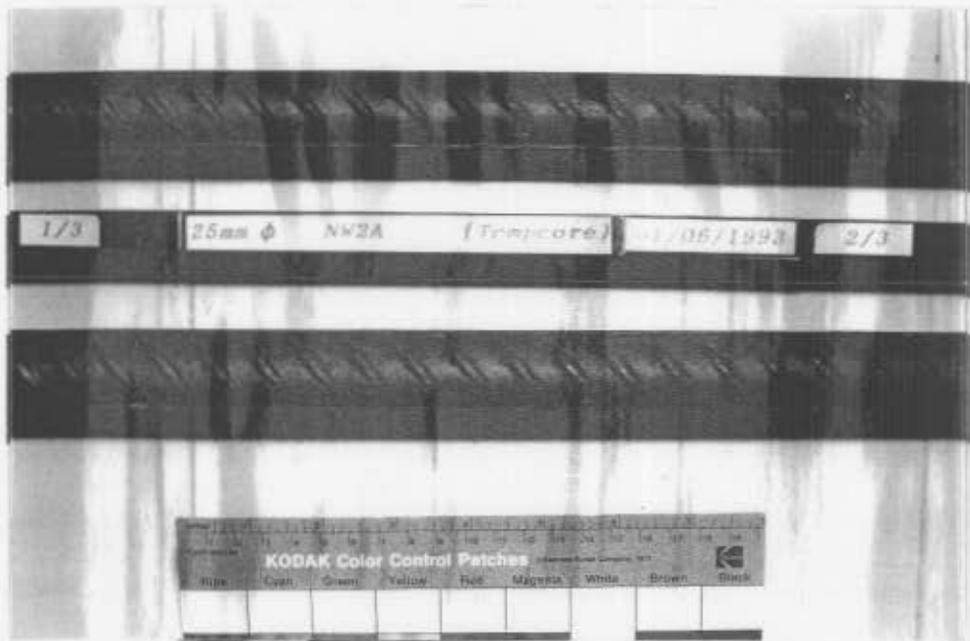
Plate 18 - Series 1, Tempcore Bars, Size 25 mm  
(taken on 1/6/93)

For the Tempcore bars, a very slight increase in surface rusting was observed after six months of storage as revealed by comparing Plates 4 and 8 for the 40mm bars and Plates 18 and 22 for the 25mm bars. However, even after seventeen months of storage, the increase in surface rusting was by no means significant as shown by comparing Plates 4 and 16 for the 40mm bars and Plates 18 and 30 for the 25mm bars.

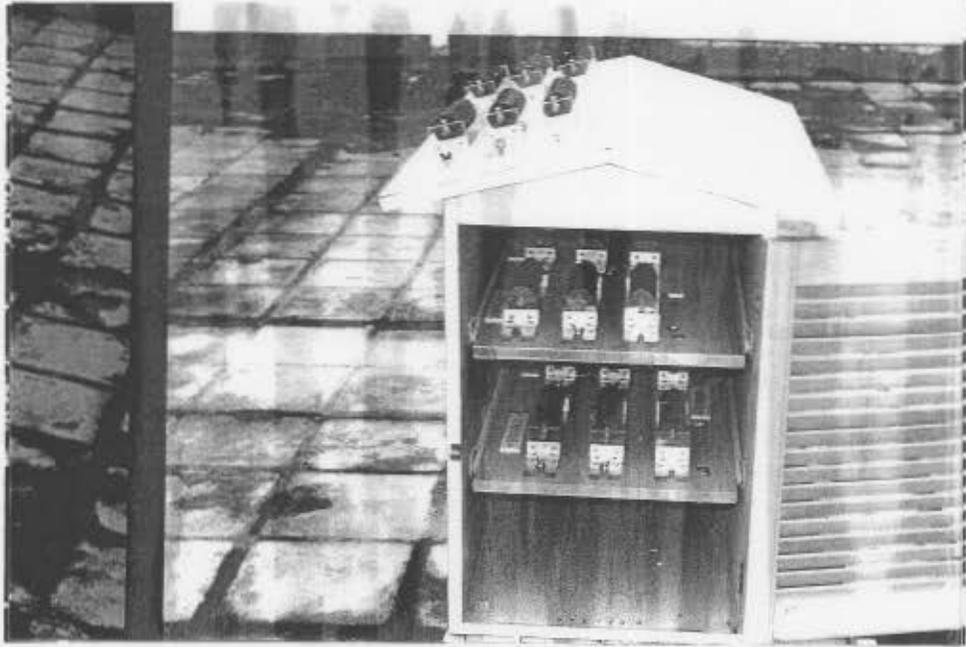
Plate 31 - Holding Rack

Group 2 and 3 bars were stored inside a purpose-built ventilated shed located on the roof top of the PWCL Building. The Group 1 bars were stored on top of the shed (see Plates 31 and 32). The rusting developed on the surface of the bars was recorded by taking photographs at about monthly intervals.

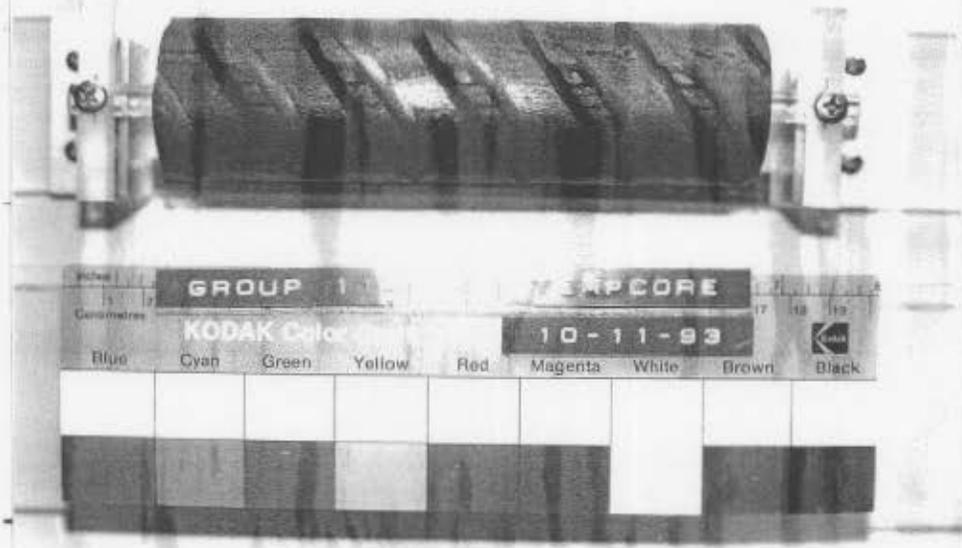
Plate 34 - Series 2, Group 1, Tempcore Bar  
(taken on 10/11/93)

At the beginning of the experiment, the surface of the conventional bar was slightly rusty but the Tempcore bar was rustless, as shown in Plates 33 and 34 respectively. After two months of exposure, it was found that the two bars had rusted to approximately the same degree by comparing the bars in Plate 35. After four months of storage, the rusting on the Tempcore bar was slightly more severe than that of the conventional bar (see Plate 36). After seven months of exposure, the surface condition of the Tempcore bar was worse than that of the conventional bar as shown in Plate 37. The surface rusting of the conventional and Tempcore bars was found to be similar to that of bars No. 8 and 7 respectively in the Rust Guide (see Plates 50 and 51). Both bars are therefore acceptable for use in construction works.

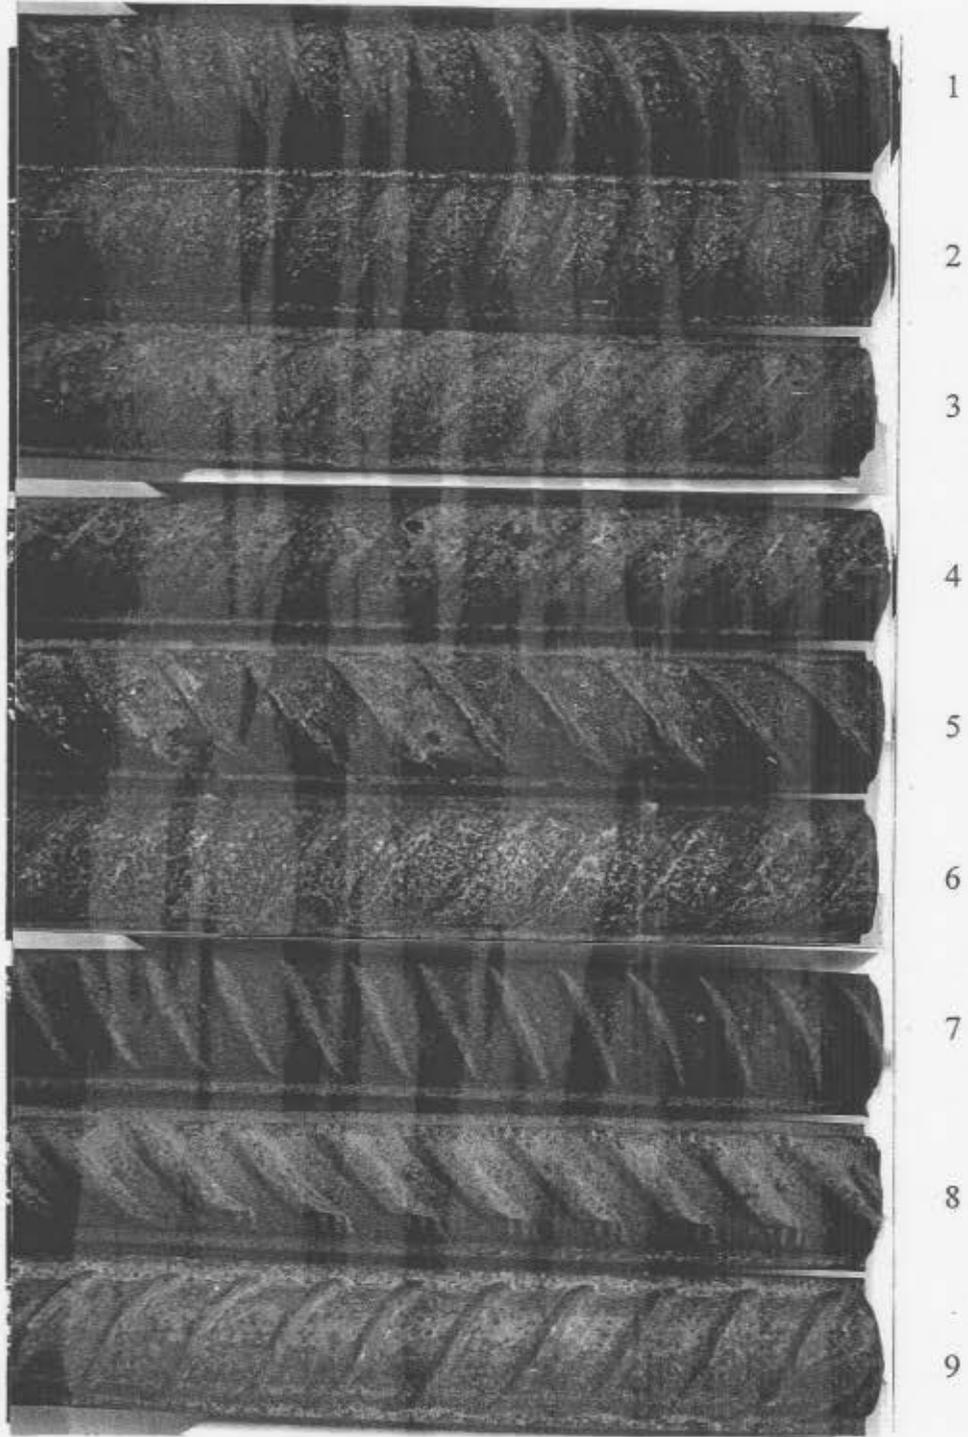
Plate 50 - Rust Guide for Steel Reinforcement Bars  
Nos. 1-6 : not acceptable; Nos. 7-18 : acceptable  
(From App. 15-A. General Specification for Civil  
Engineering Works, Guidance Notes, 1992)

The Rust Guide for Steel Reinforcement Bars in Appendix 15A of the Guidance Notes to the General Specification (GS) for Civil Engineering Works (Hong Kong Government, 1992) is reproduced in Plates 50 and 51 for reference by readers of this Report. Based on the Guidance Notes, bars Nos. 1 to 6 in Plate 50 are classified to have corroded to an extent which renders them unsuitable for use in construction works. Bars Nos. 7 to 18 are acceptable.

Compared with the bars in the Rust Guide of the GS Guidance Notes (see Plates 50 and 51), the surface rusting of the conventional bars after seventeen months of storage was found to be similar to that of bars Nos. 11 and 12 on the Rust Guide. They are therefore acceptable for use in construction works. For the Tempcore bars, the surface rusting condition after seventeen months of storage was found to be similar to bars Nos. 9 and 10 on the Rust Guide. They are therefore also acceptable.
