Eco-driven Repair Mortar Technology Recycled Glass and Slag Based Approach

Ir Dr Jeffery Lam & Dr Garrison Chau
Construction and Building Materials Sector
Nano and Advanced Materials Institute

9 May 2018

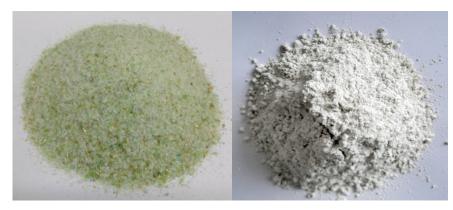
Raw materials

Recycled Glass

Ground Granulated

Blast-furnace Slag

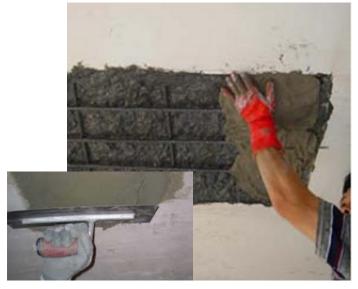
Typical Repair Location

- Various locations with the following conditions were repaired to demonstrate the applicability of green repair mortar
 - ❖ Size of repair area (e.g. 500mm×500mm)
 - Depth of repair area
 - Grade of substrate concrete (e.g. C25 or C30)
 - Outdoor or indoor
 - Moisture condition

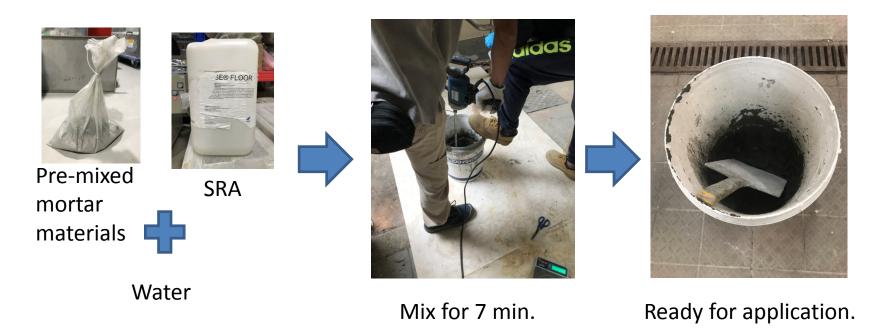
Trial application procedure (1/2)

• **Preparation of mortar:** mortar material and shrinkage reducing agent (SRA) aqueous solution were allowed to be mixed with a handheld mixer for 7 min.

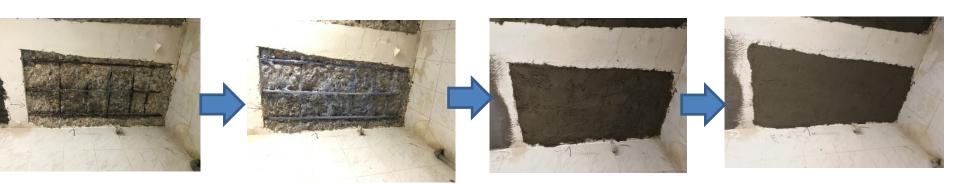
Application of bond coat and mortar

To hack off defective concrete and remove steel bar rust.

To apply a layer of bond coat.

To apply a layer of repair mortar (1st layer).

To touch up the final layer.

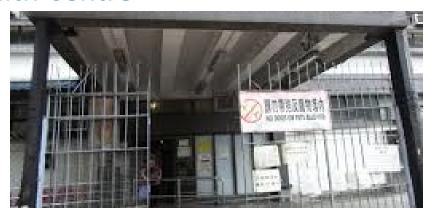
Health Centre

Below windows of staircase

Ceiling at toilet

Wall at the outdoor roof

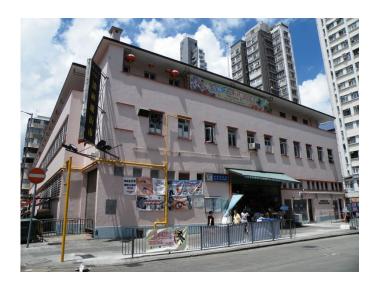
Public Market

Ceiling at 2/F

Beam on 2/F

Parapet along the corridor

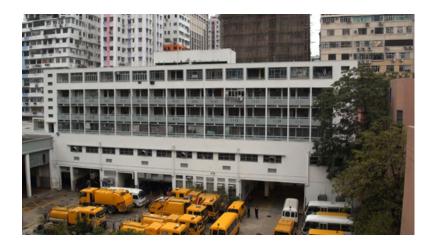
Government Quarters

Three locations at 5/F of ceiling beams

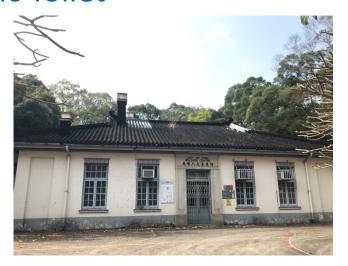
Public Toilet

Ceiling at Female Toilet

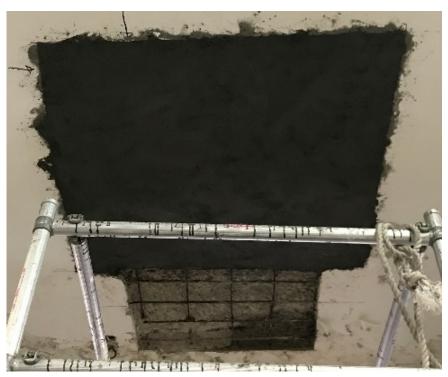
Public Market

Ceiling

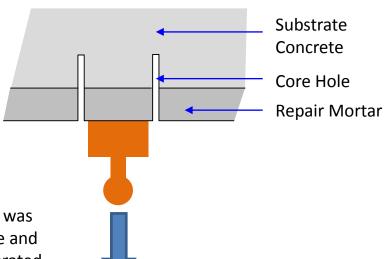
Identify re-bar position

75mm dia. core containing full thickness of the repair

A suitable metal plate was glued to the cored hole and was pulled using a calibrated device until failure occurs.

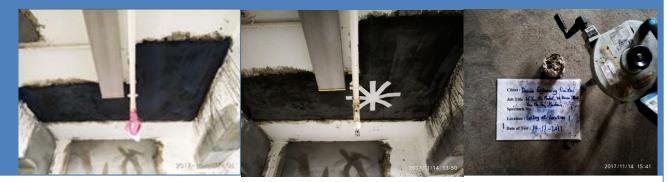
Pull-off Test

Site	Results and Comments		
	Location 1	Location 2	Location 3
Health Centre PASS	There are 50% failure in both mortar and concrete substrate.	Pull-off strength is 0.75MPa.	The failure mode is 100% in the concrete substrate.
	Location 1	Location 2	Location 3
Public Market PASS	The failure mode is 100% in the concrete substrate.	The failure mode is 100% in the concrete substrate.	Pull-off strength is 0.6MPa.
