## **Annual Concrete Seminar 2019**

# **Different Methods to Improve Performance of Concrete under Fire, and to Quantify Residual Properties of Fire Damaged Concrete in Buildings**

**Ir Prof. Y.L. WONG**

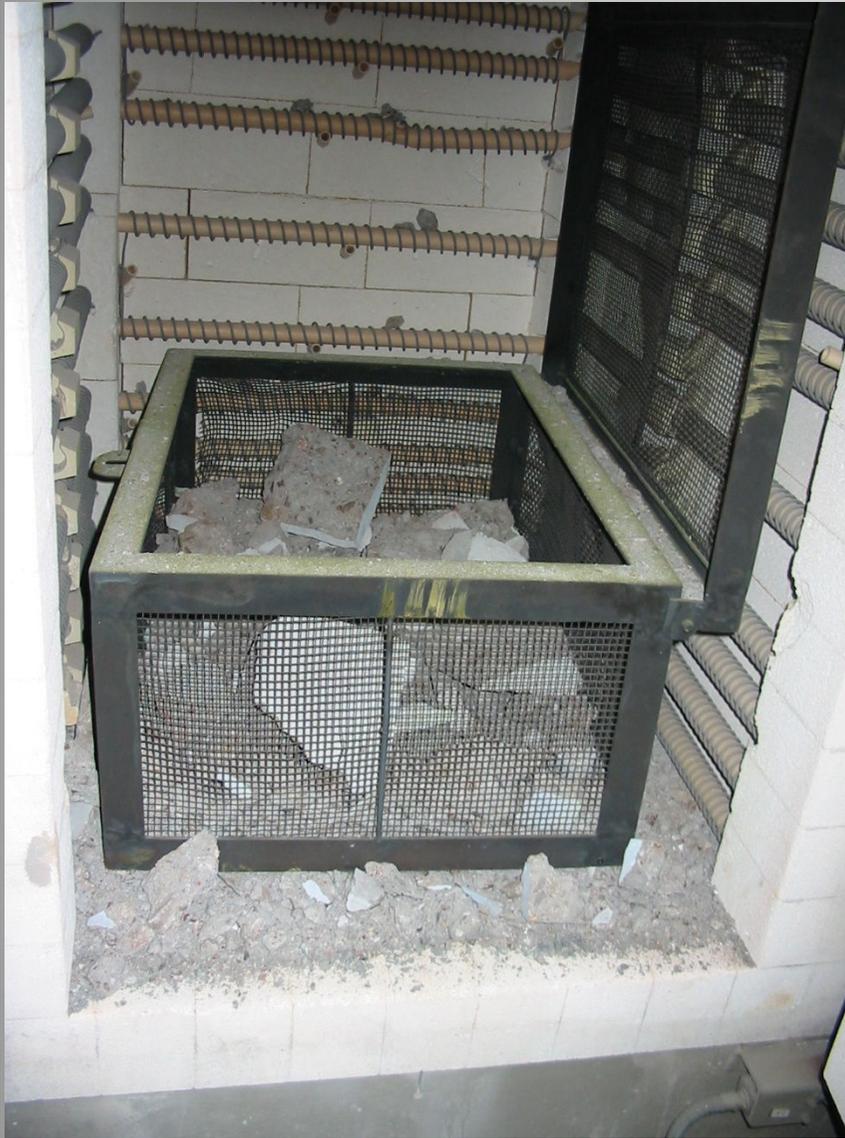
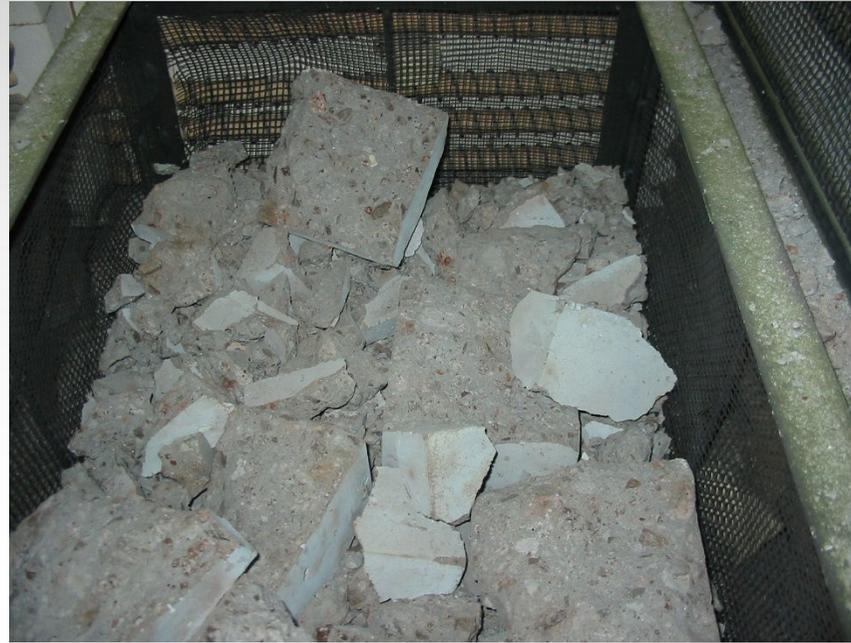
High strength concrete (HSC) with granite aggregates fully saturated with water, Heating rate =  $2^{\circ}\text{C}/\text{minute}$ , spalled at about  $450^{\circ}\text{C}$

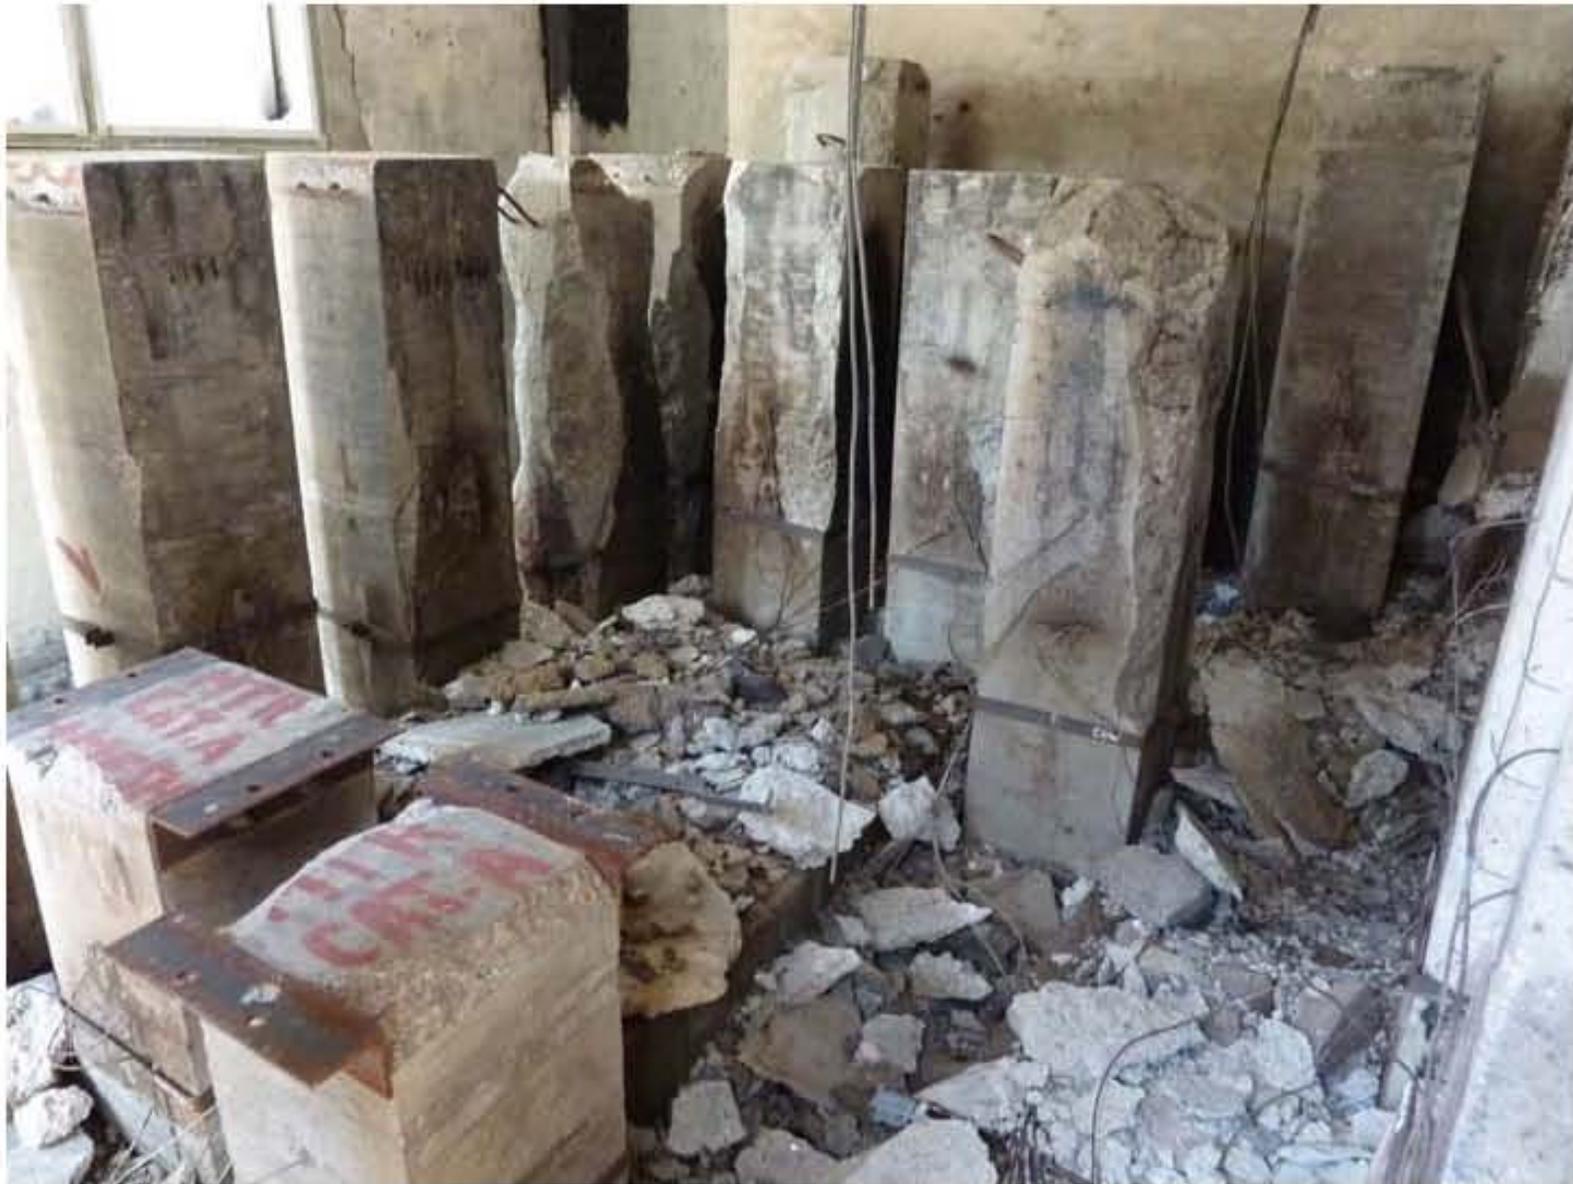
**Figure 5: Fire-Damaged Test Columns (with Water Quenching)**

Column	Remarks	Spalled Area (% of total vertical surface areas of column)			
		Class 1	Class 2	Class 3	$\Sigma$
R1W	C40	2	29	5	36
R11NW	C40 with 100 x 100 x 2 steel mesh	2	22	11	35
M7BW	C40A	5	0	0	5
M7TW	C40A with 50 x 50 x 2.6 steel mesh	2	0	0	2
M8BW	C40Ab with 1.0 kg/m <sup>3</sup> pp fibre	0	0	0	0
M8TW	C40Ab with 1.0 kg/m <sup>3</sup> pp fibre and 50 x 50 x 2.6 steel mesh	0	0	0	0
R2W	C60	49	2	3	54
R8NW	C60b with 1.0 kg/m <sup>3</sup> pp fibre	1	1	1	3
R3W	C90	2	28	25	55
R9W	C90 with 20mm Mg Si board coating	2	11	15	28
R10W	C90 with vermiculate cement coating	1	5	0	6
R4W	C90a with 0.6 kg/m <sup>3</sup> pp fibre	2	0	0	2
R5W	C90b with 1.0 kg/m <sup>3</sup> pp fibre	0	0	0	0

- (i) Without adopting one of the above-mentioned EN methods to suppress concrete spalling under fire, the severity of concrete cover spalling increased with the cube strength of the test columns. Concrete spalling often occurred at the corners of the columns.
- (ii) Water quenching has an insignificant adverse effect on the concrete cover spalling. This might be due to the fact that most of the concrete cover spalling and macro-crack formation happened in the first hour of fire (air temperature less than 600C). Further sustained fire or increase in fire temperature would lead to more degradation or decomposition of the concrete matrix but the mechanism of concrete spalling basically ceased. As water quenching was applied to the columns at the fire time of 2 hours and 28 minutes, the temperature shock so induced might cause concrete further cracking or crack opening but not spalling.

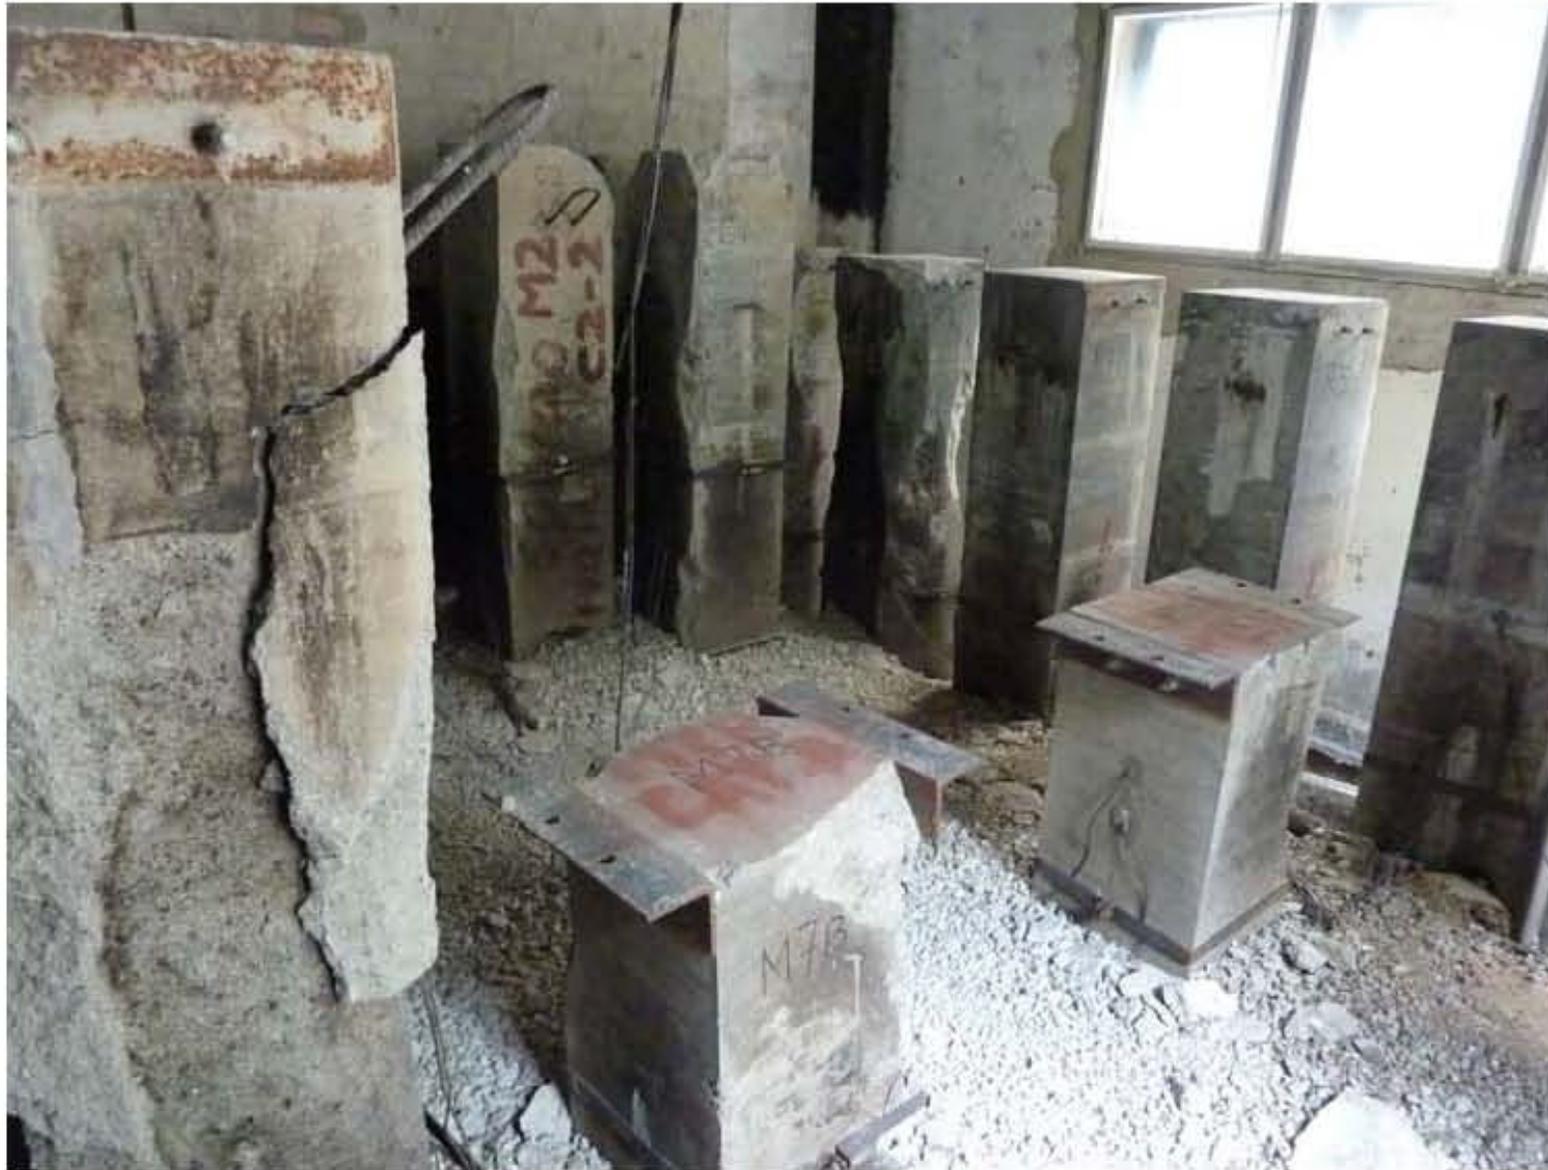
**Figure 6: Fire-Damaged Test Columns (without Water Quenching)**

Column	Remarks	Spalled Area (% of total vertical surface areas of column)			
		Class 1	Class 2	Class 3	$\Sigma$
R1	C40	13	3	5	21
R11N	C40 with 100 x 100 x 2 steel mesh	7	20	0	27
M7B	C40A	12	5	0	17
M7T	C40A with 50 x 50 x 2.6 steel mesh	5	0	0	5
M8B	C40Ab with 1.0 kg/m <sup>3</sup> pp fibre	0	0	0	0
M8T	C40Ab with 1.0 kg/m <sup>3</sup> pp fibre and 50 x 50 x 2.6 steel mesh	0	0	0	0
R2	C60	8	25	0	43
R8N	C60b with 1.0 kg/m <sup>3</sup> pp fibre	0	0	0	0
R3	C90	35	10	2	47
R9	C90 with 20mm Mg Si board coating	24	0	0	24
R10	C90 with vermiculate cement coating	0	0	0	0
R4	C90a with 0.6 kg/m <sup>3</sup> pp fibre	1	0	0	1
R5	C90b with 1.0 kg/m <sup>3</sup> pp fibre	0	0	0	0

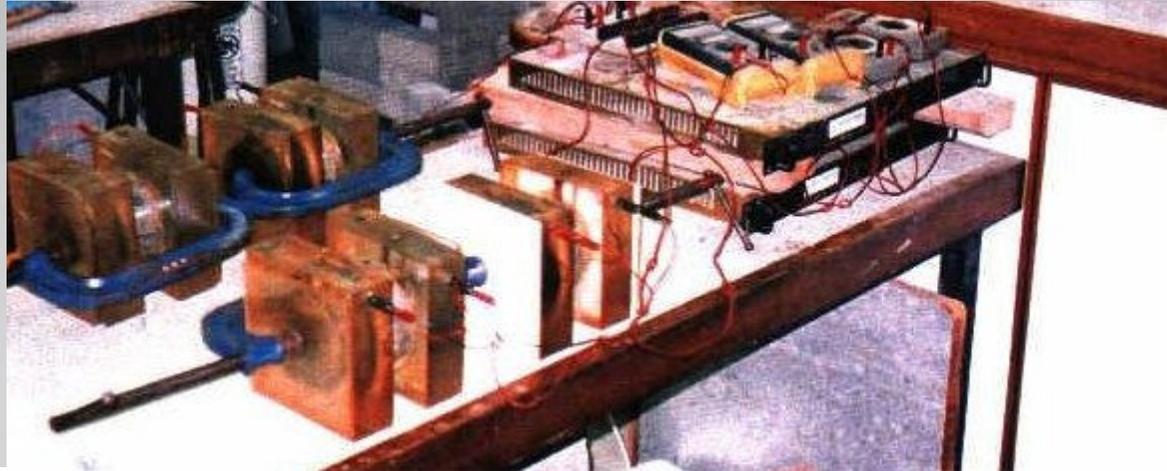
## Rapid Chloride Penetration Test (ASTM C1202-97)

Charge passed (coulombs)	Chloride-ions penetrability
> 4,000	high
2,000 – 4,000	moderate
1,000 – 2,000	low
100 – 1,000	very low
< 100	negligible
