Fiber Reinforced Mortar for the Repair of Concrete Slab with Significant Loss of Steel Area due to Corrosion

Christopher K.Y. Leung

**Dept of Civil and Environmental Engineering
Hong Kong University of Science and Technology**

Presentation at SCCT Annual Concrete Seminar, 2nd April, 2019

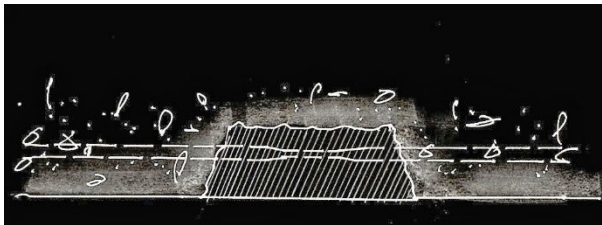
(2)

- Carry out patching using fiber reinforced repair mortar;
- Inspect completed repair works

- ✓ *Exposed concrete area for lapping greatly reduced*
- ✓ *Simplified repair process with savings in labor and cost*
- ✓ *Shorter time to commence repairing with less dust and noise*

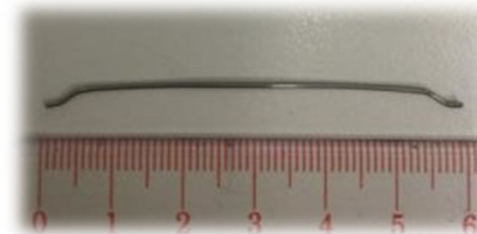
0.65mm × 60mm
Aspect ratio = 92.3

- ❑ The target strength of 3.5MPa can be achieved for several kinds of mortar by adding 2% of fiber with aspect ratio of 92.3 (60mm length and 0.65mm diameter)
- ❑ Based on the direct tensile test and instant thickness test, the following mortars (with fiber) were considered suitable for further tests
 - Mapei
 - Ronacrete
 - Chunwo-NAMI
- ❑ Other mortars should NOT be considered inferior
 - they may perform well with other kinds of fibers
 - None of the mortars are designed for use with fibers. If there is a market, compositions can be modified

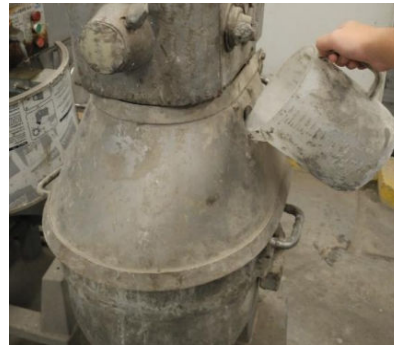
Mix mortar with mixing machine for 5mins and add water gradually during the mixing

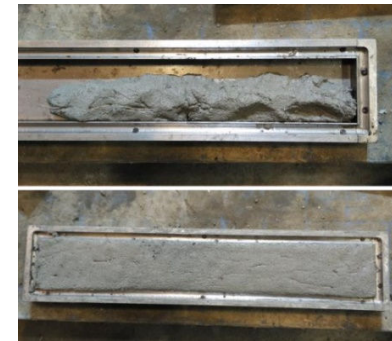
- Squeeze fiber mortar into strips
- Strips placed in such a way to enhance fiber alignment along loading direction

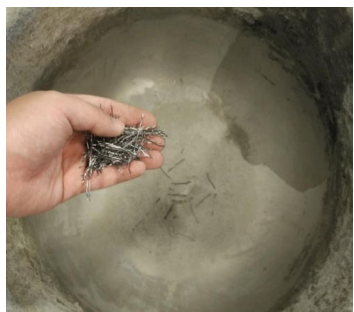
Disperse short fibers into dry mortar

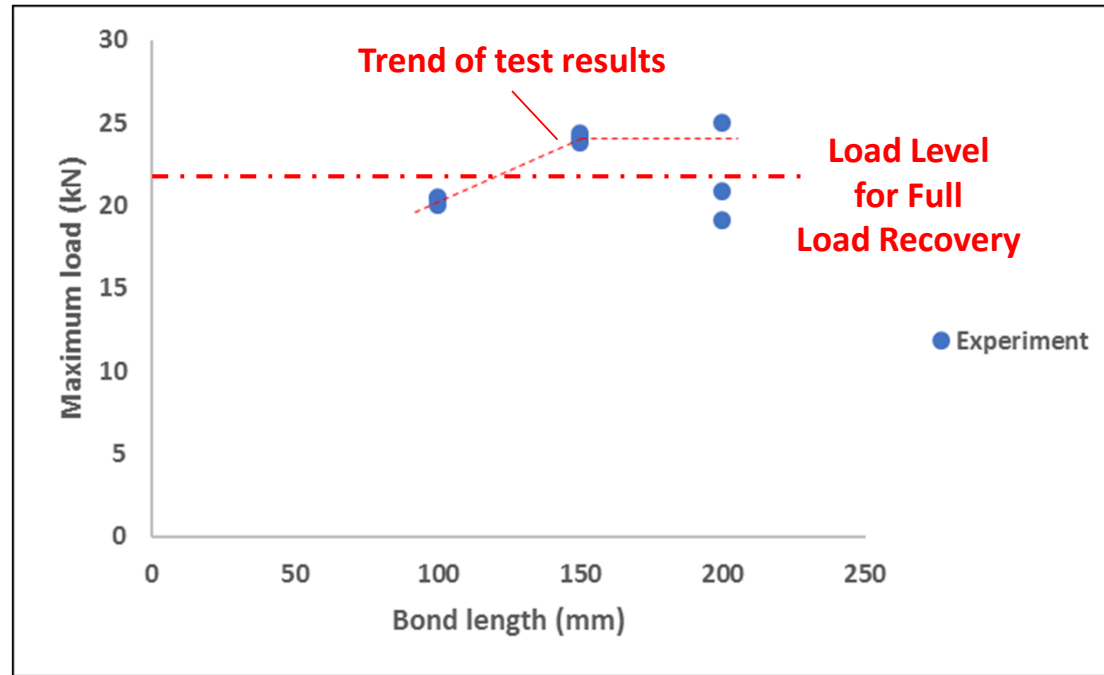
Results for one repair mortar

- ❑ 150mm bond length is sufficient to recover full strength of 250MPa rebar
- ❑ With 100mm bond length, over 90% of the load capacity can be recovered
- ❑ Further studies on slabs will be performed with 100mm and 150mm bond length

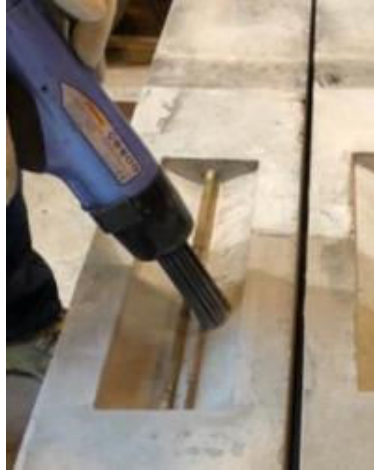
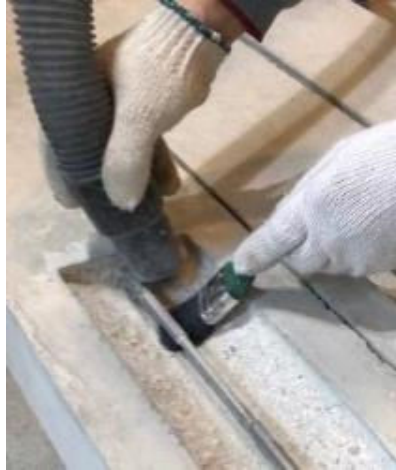
1) Roughen concrete substrate by vibrating needle gun

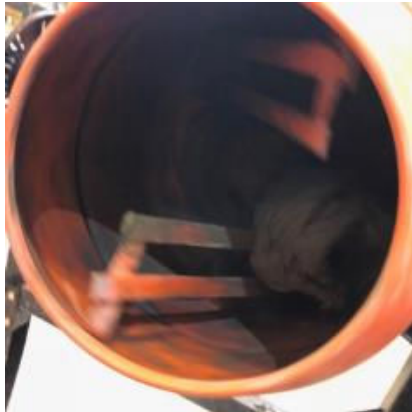
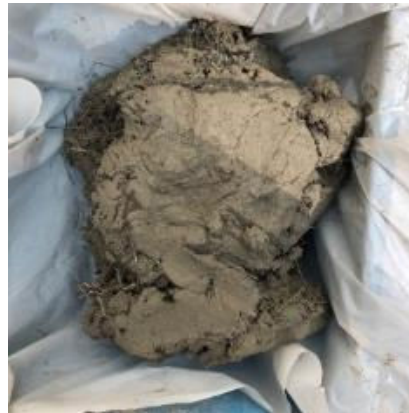
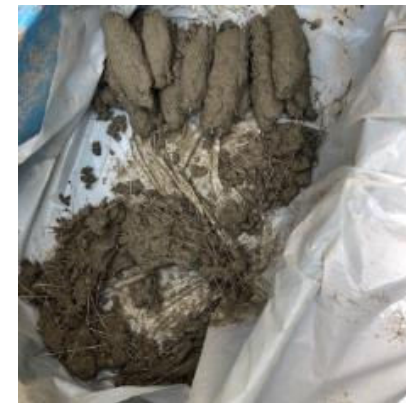
2) Prepare mortar composite according to the developed mixing procedure

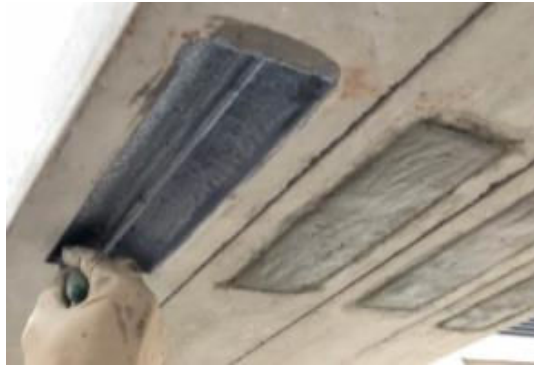
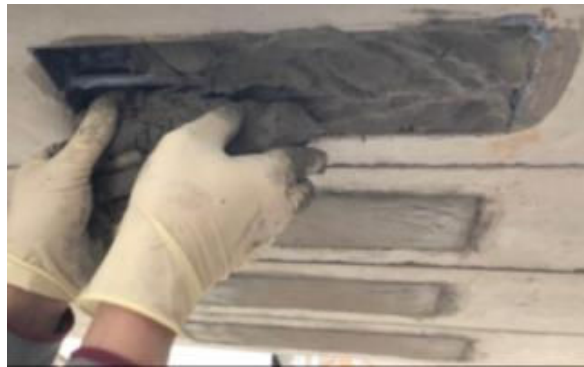
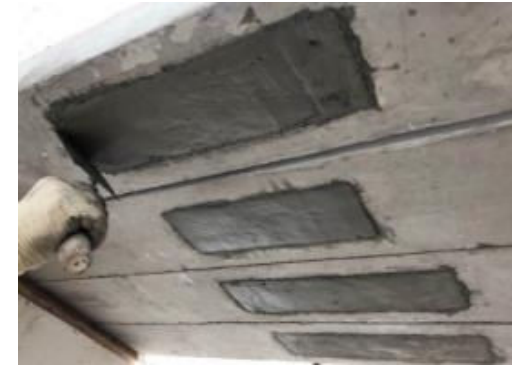
3) Prepare mortar composite according to a standard mixing procedure

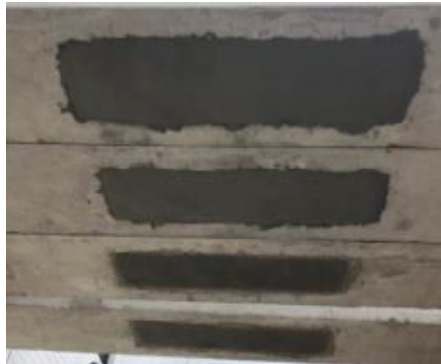
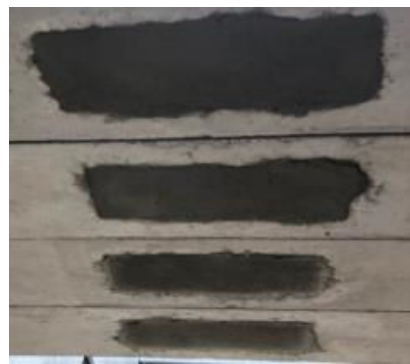
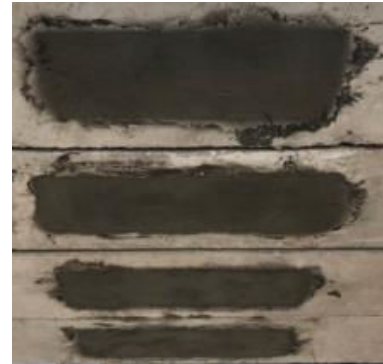
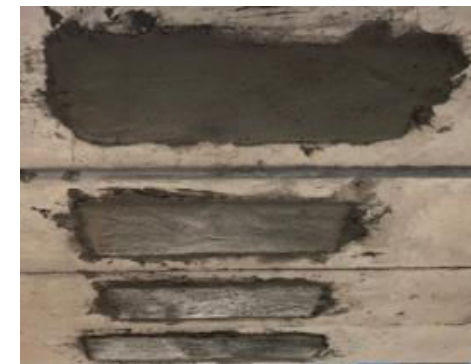
4) Final patched beams

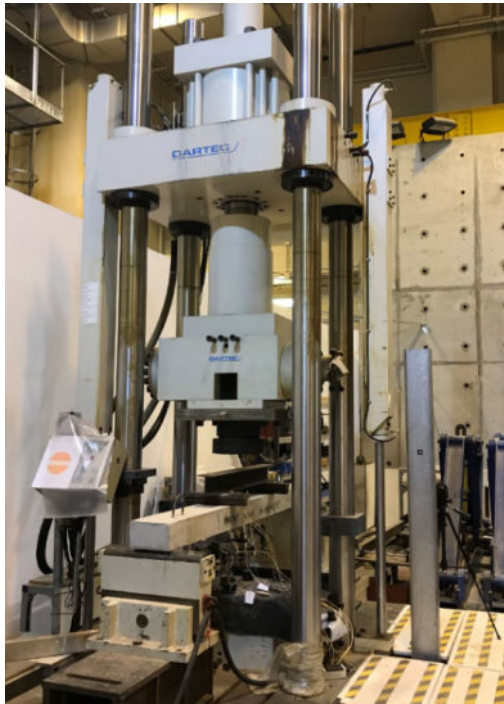
- ❑ The beams span was 1.9 m. Two point loads were applied at one-third and two-third of beam span.
- ❑ The beam specimens were conducted with displacement control mode at the rate of 0.01mm/sec.

Test Setup

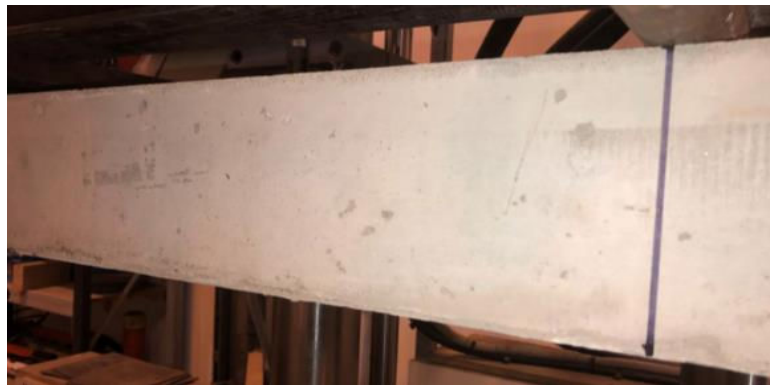
- ❑ Additional beams have been prepared for cyclic bending test
- ❑ Very extreme condition with 10 cycles of full live load per day over 30 years, giving a total of 110,000 cycles
- ❑ After the test, the beam specimens remained intact. No visual crack or debonding was observed.
- ❑ Flexural strength was similar to those directly loaded to failure.

Side Face (No crack observed)

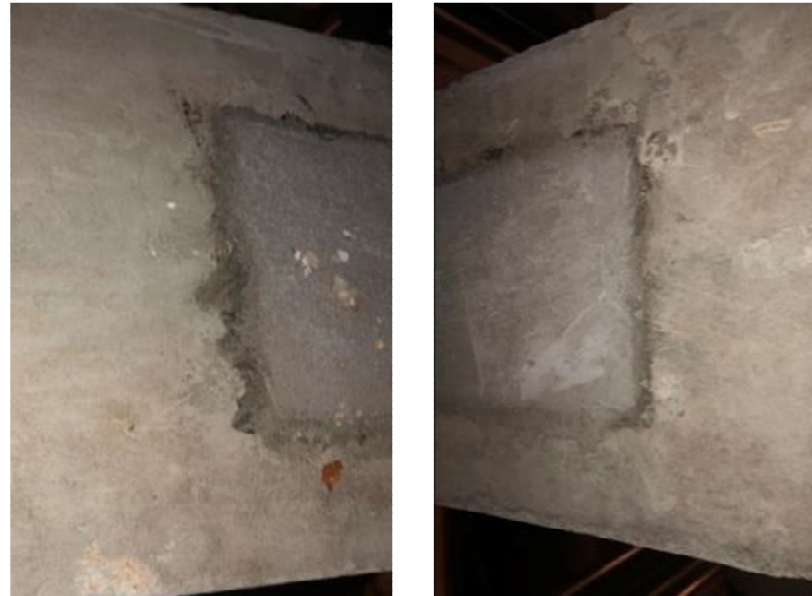
Bottom Face (No debonding found at the concrete/mortar interface)

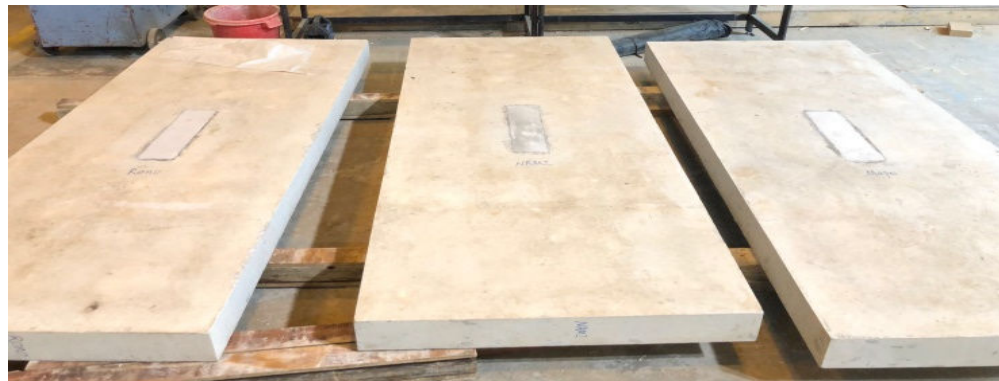
Specimens before Fire Testing

- ❑ Four specimens prepared for fire testing, one control and three with one of the steel rebars exhibiting 40% area reduction, repaired using fiber reinforced mortar
- ❑ For the repair, the bond length on each side was 150mm
- ❑ Following code requirements, specimens were loaded with dead weight equivalent to 5kPa during fire exposure

Ronacrete
Unicell 25

NAMI-RM

Mapei HB25

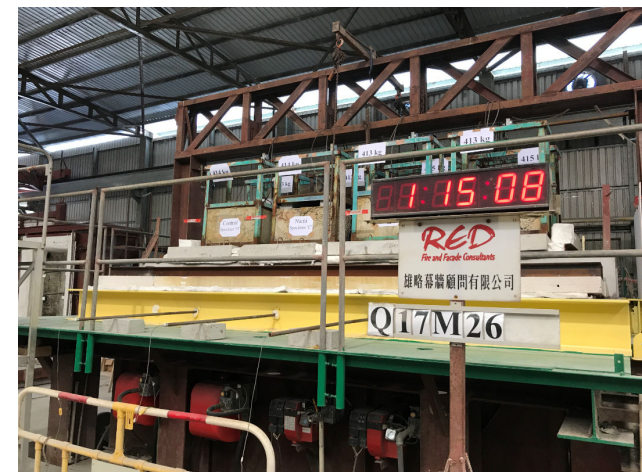
Fire Testing Set-up

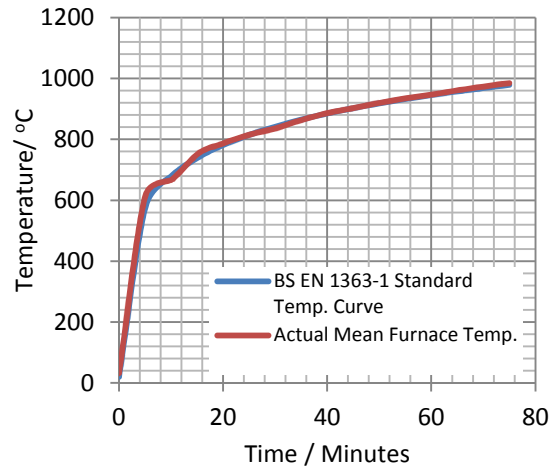
Temperature vs time curve according to BS EN 1363-1

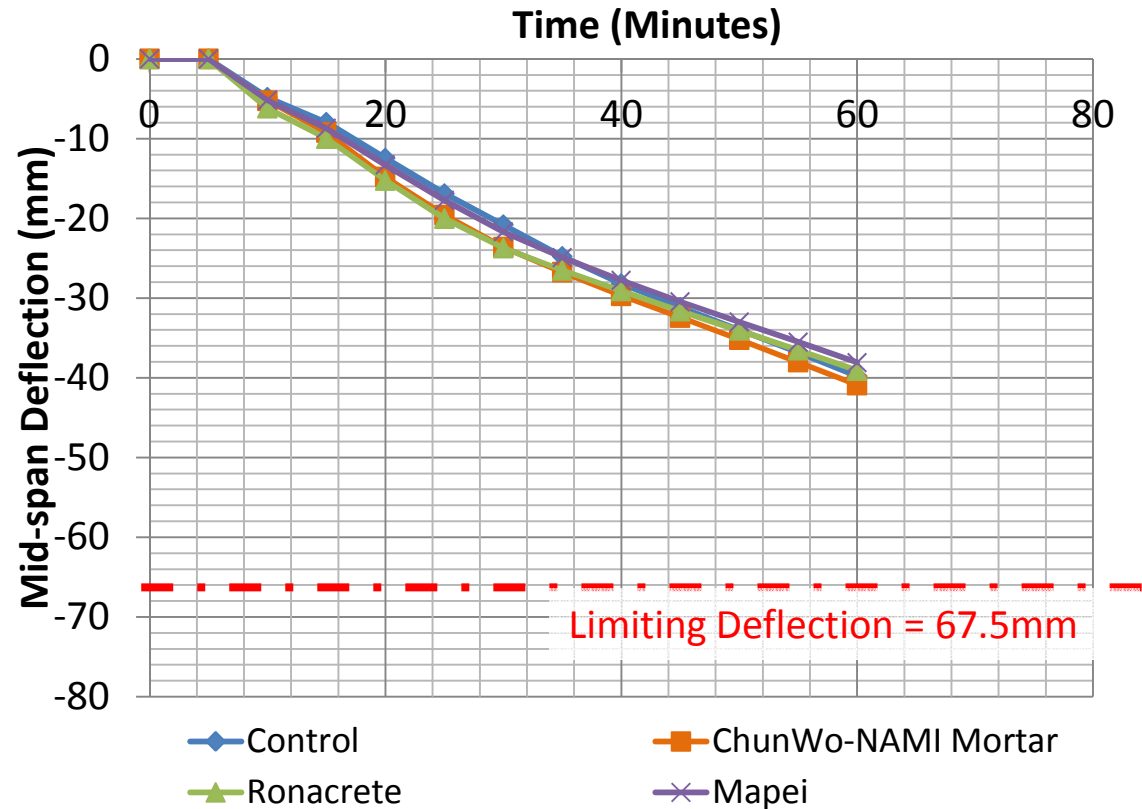
- The deflection of all four specimens was within the deflection limit and deflection rate limit specified in the fire test standard.

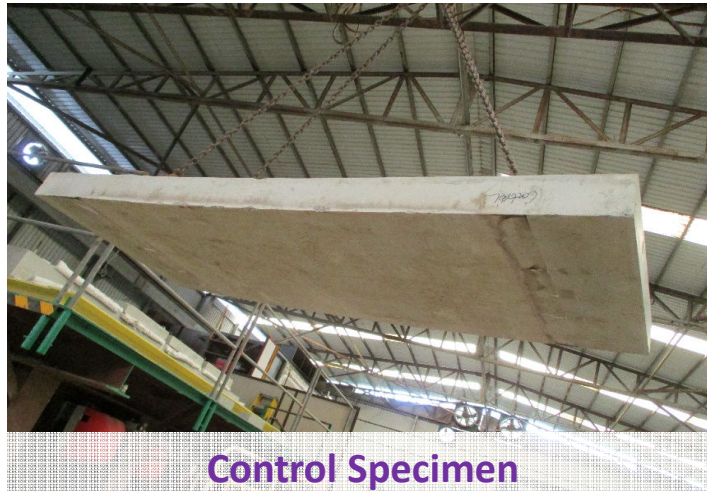
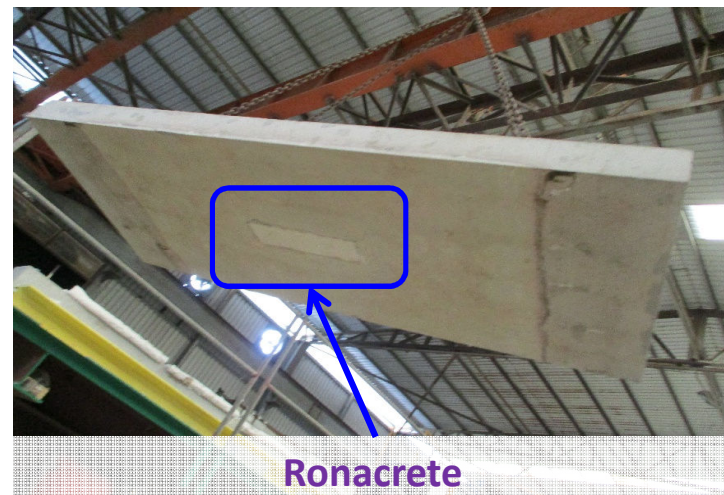
Slab specimens after fire test

No cracking or separation identified in the repaired patch

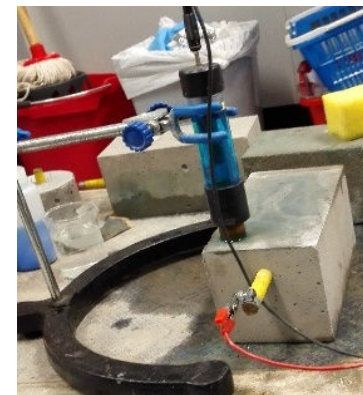
- Self-corrosion in repair mortar with and without fibers
- Both half cell potential and corrosion current are measured
- The specimens with steel fibers show lower corrosion current and less negative potential
 - Fibers DO NOT increase the rate of corrosion

Half-cell potential measurement

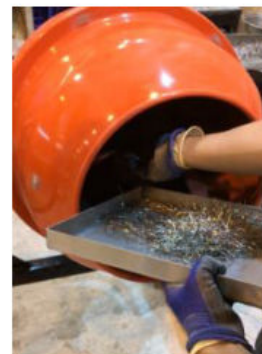
- Dry powder of fixed composition and weight, and a fixed weight of stainless steel fibers, will be packed in separate bags
- In the field, a standard amount of water will be added to the powder, followed by mixing in an electric mixer according to a standard process
- The mortar is then transferred to the drum mixer where fibers are added. Further standard mixing is performed.

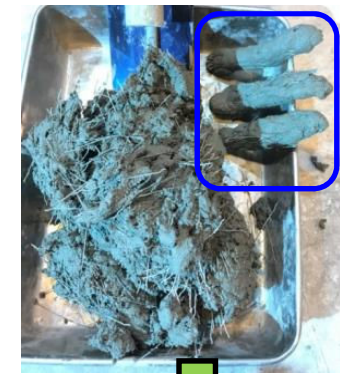
- Repair mortar is made in a number of strips (e.g. 20mm in diameter and 80mm in length) and placed with the long direction along the existing rebar to **enhance fiber alignment along loading direction**
- The strips should be patched in a **staggered arrangement** along the rebar direction, from one end to the other
- Intermediate layers should be keyed and primed before the next layer is applied.
- Similar to conventional practice, care should be taken to ensure all space (including those behind the rebar) are properly filled
- External surface of repair should be leveled with existing surface and be properly finished

R2M2 Strips

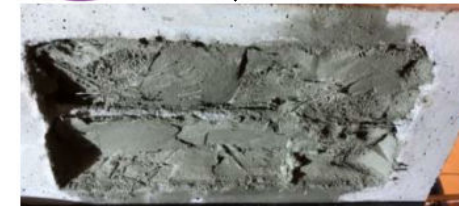
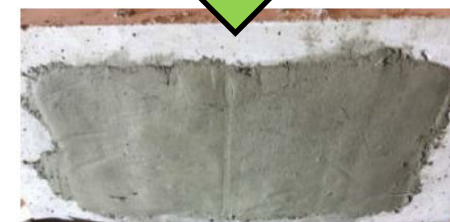
Finished Surface
