ASSESSMENT OF THE RESISTANCE OF STAINLESS STEEL CLAD BARS TO CHLORIDE-INDUCED CORROSION IN CONCRETE

Gerardo G. Clemeña, Ph.D.
Principal Research Scientist (Ret.)
Virginia Transportation Research Council*
Charlottesville, Virginia

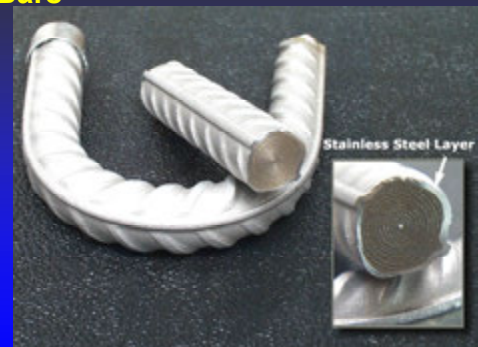
Stainless Steel-Clad Carbon Steel Bars

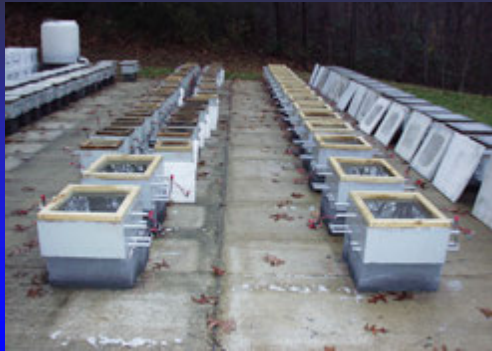
Exposure of the Concrete Blocks

1. Embedded the clad bars in concrete blocks (almost similar to ASTM G109).
2. Weekly exposed the blocks to 3 days of ponding with a NaCl solution and 4 days of drying.

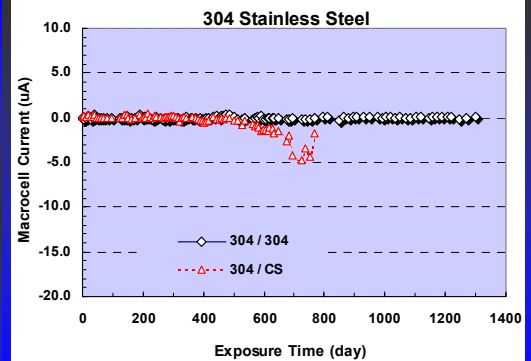
Time-to-Corrosion > 1,300 days

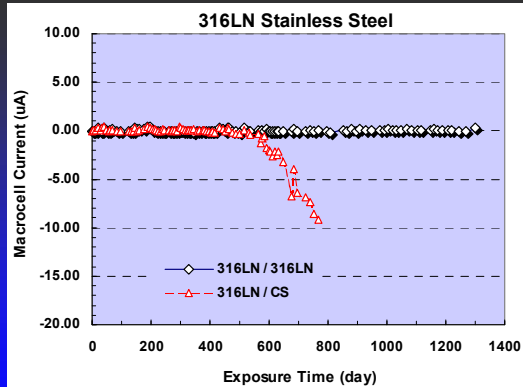
Time-to-Corrosion > 1,300 days

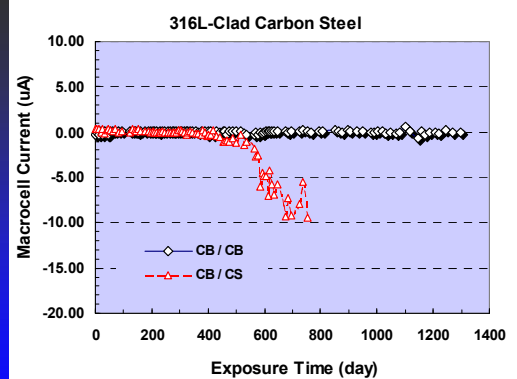
Time-to-Corrosion > 1,300 days

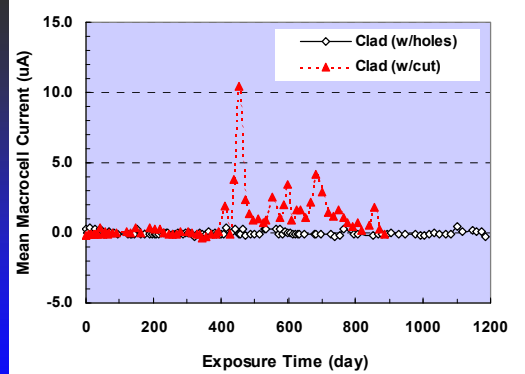
$T_{\text{clad w/ holes}} > 1,300 \text{ days}$
 $T_{\text{clad w/ cut}} = 392 \pm 3 \text{ days}$

Bar	Time-to-Corrosion (day)
Carbon Steel	92 ± 3
340 Stainless	$> 1,300$
316LN Stainless	$> 1,300$
316L-Clad (no defect)	$> 1,300$
316L-Clad (w/ holes)	$> 1,300$
316L-Clad (w/ cut)	392

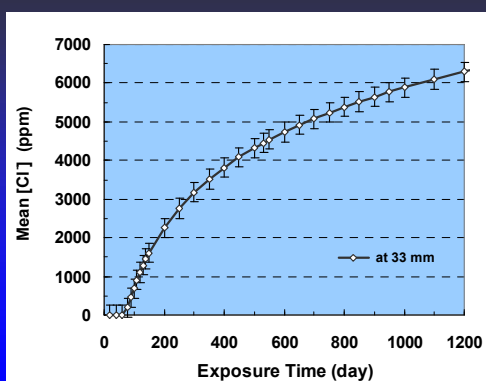
[Cl⁻] vs. Depth (in Concrete)
 vs. Exposure Time

The best-fit curve relating [Cl⁻], at depth of top bars, to exposure time.

Bar	[CL ⁻] _{corr.} (ppm)	Ratio
Carbon Steel	430 - 580	1.0
340	$> 6,470^*$	$> 11.2 - 14.2^*$
316LN	$> 6,470^*$	$> 11.2 - 14.2^*$
316L-Clad	$> 6,470^*$	$> 11.2 - 14.2^*$
316L-Clad (w/holes)	$> 6,470^*$	$> 11.2 - 14.2^*$
316L-Clad (w/cut)	3,750 - 3,790	6.5 - 8.8

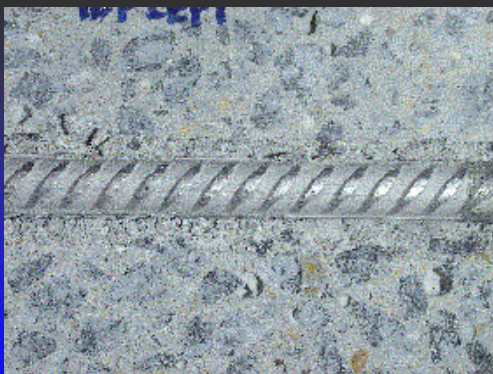
A 316 LN Stainless Steel Bar

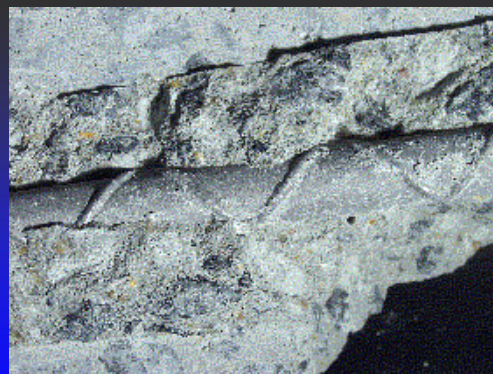
A 340 Stainless Steel Bar
