Knowing the cause of concrete deterioration and finding the right repair solution

Ir Dr HW Pang

18 April 2012

How long can a reinforced concrete building serve us?

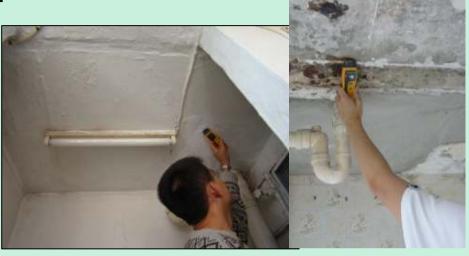
Moisture Survey

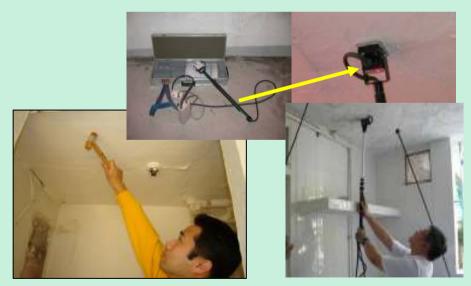
Tapping Test

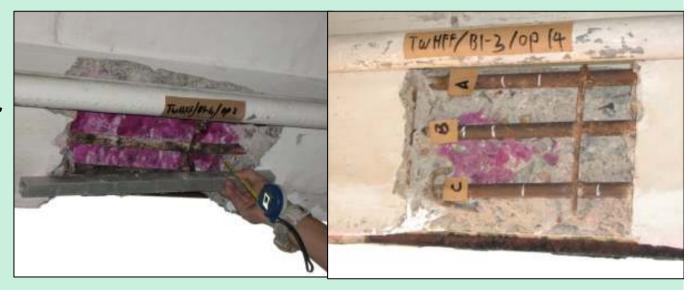
Open-ups, measurements and tests

- 1. Steel bar size and spacing
- 2. Concrete cover
- 3. Carbonation depth

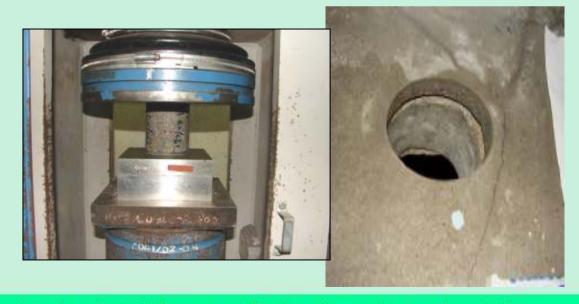
Core compression test

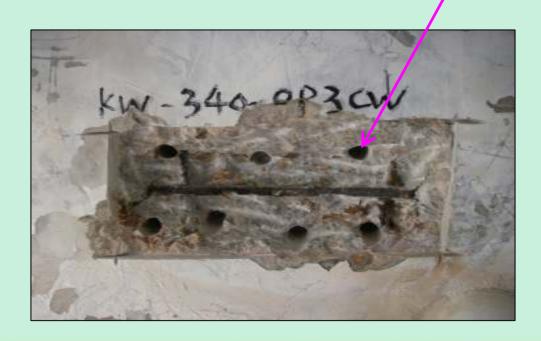
Hole drilling to extract concrete powder for chloride diagnosis

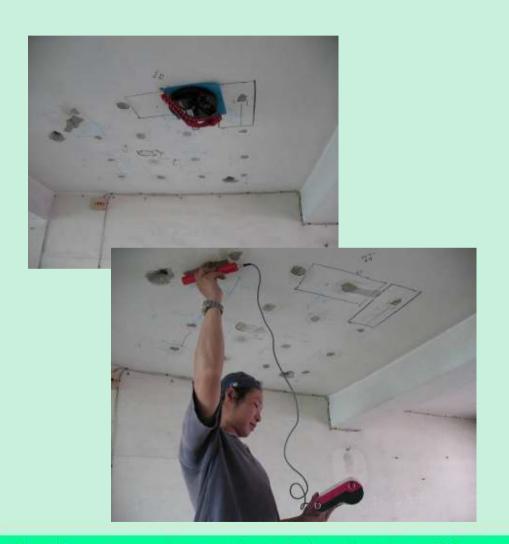
Re-bar Corrosion Rate measurement

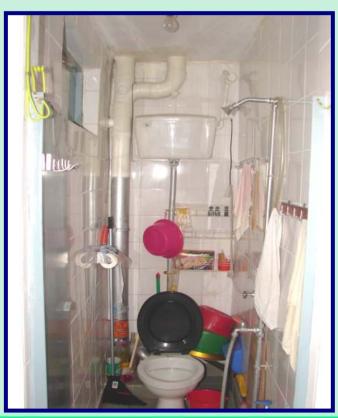
- Earlier design weak in durability
 - Lower concrete strength
 - Small cover to re-bars
 - Toilet-bathroom layout design
 - Little waterproofing
- Sea water for flushing toilet

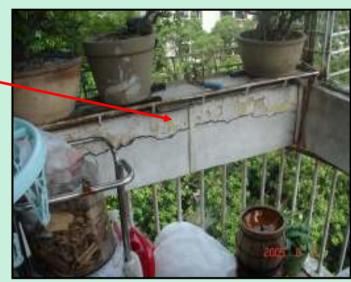
Air-borne chloride near the sea

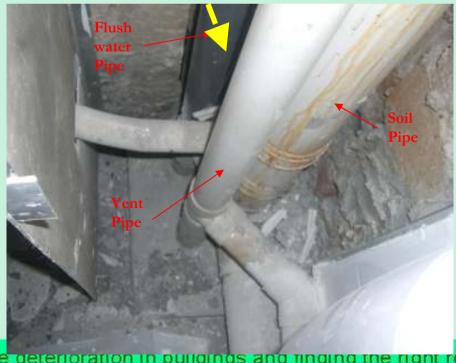
Inspection panel required

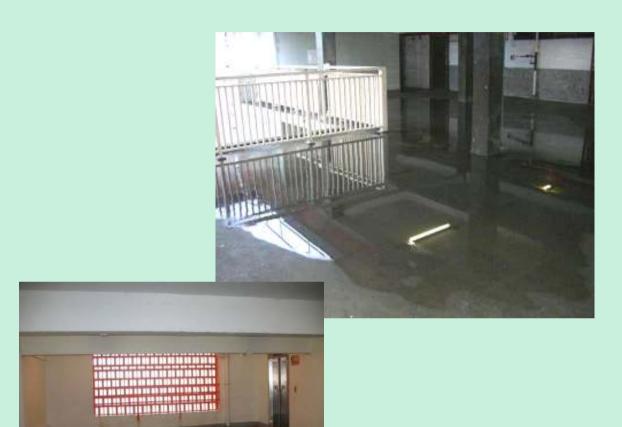
Solution: lay screed with adequate fall

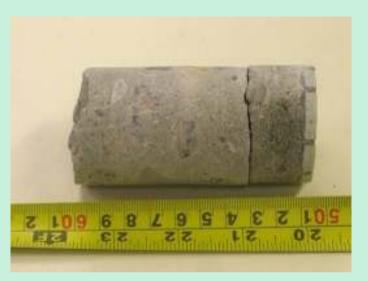
Loose bedding under floor tiles promotes undesirable aquaduct effect

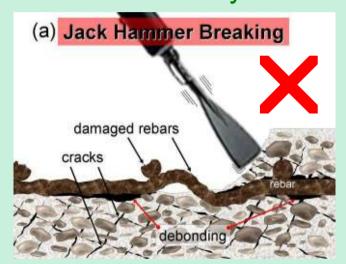
Environmental Friendly Concrete Removal Method: Hydro-Scarification

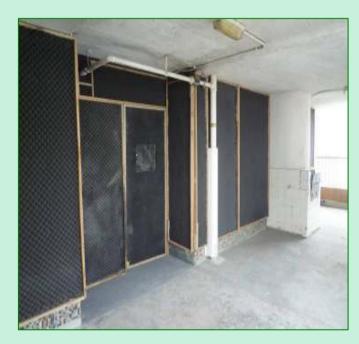
Noise Absorbent Curtains at working areas to reduce noise and dust

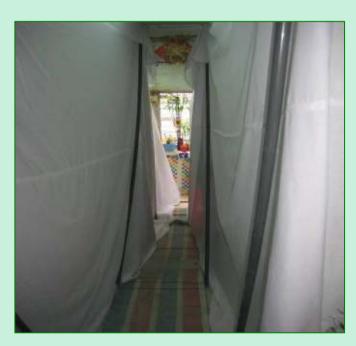
Dust Screen Protection in Tenant's Flat

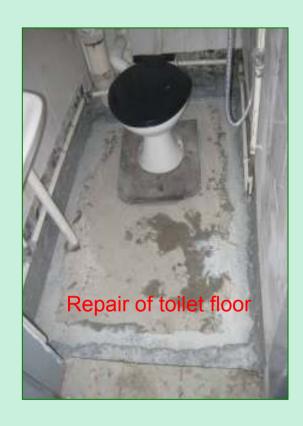
Temporary toilet installed in tenant's flat after day 1 work

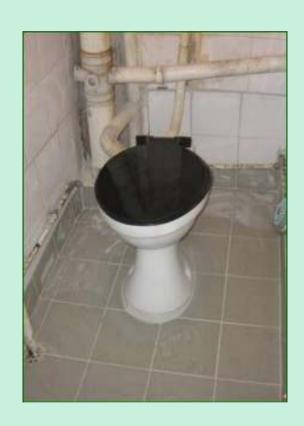
Completion of Toilet Improvement (day 2)
