**Report of the Task Force on
Investigation of Excessive
Lead Content in Drinking Water**

October 2015

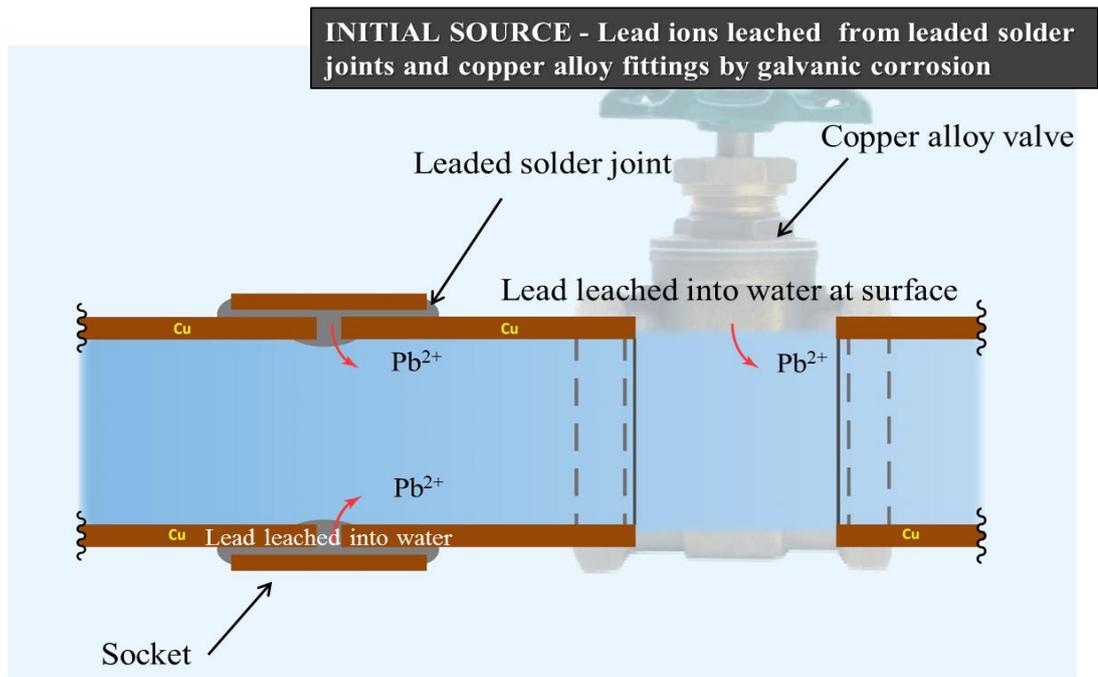
Figure 2.8(a) Leaching of lead from leaded solder joints and copper alloy fittings

2.8.1 The mechanism for lead leaching from copper alloy fittings and leaded solder joints in contact with water is the formation of a corrosion cell between the lead and the copper resulting in galvanic corrosion. Under this setting, copper acts as the cathode metal, lead acts as the anode metal and water is the electrolyte medium. As lead has a greater tendency to lose electrons to form positive ions than does copper, lead ions leach into water as a result of galvanic corrosion and the process is shown in **Figure 2.7**.

2.8.2 Reaction of lead ions with carbonate ions and hydroxide ions in water may form insoluble lead carbonates or lead hydroxides at or near the surfaces where lead ions are released due to the low solubilities of the carbonates and hydroxides and the relatively higher concentrations of the lead ions under stagnant conditions. The insoluble compounds may deposit locally or be drifted downstream and deposit on other surfaces in contact as alien matters. The formation of lead compounds was identified by

analysis of the deposits cleansed from some of the components of the water supply chains. The test results shown in **Annex 2.5** indicated the presence of lead compounds in the deposits which could also release lead into the drinking water by dissolution as lead ions and by suspension as small particles of lead compounds from the deposits. **Figure 2.8 (a)-(c)** illustrates the process of formation of lead containing deposits and release of lead into drinking water from the deposits.

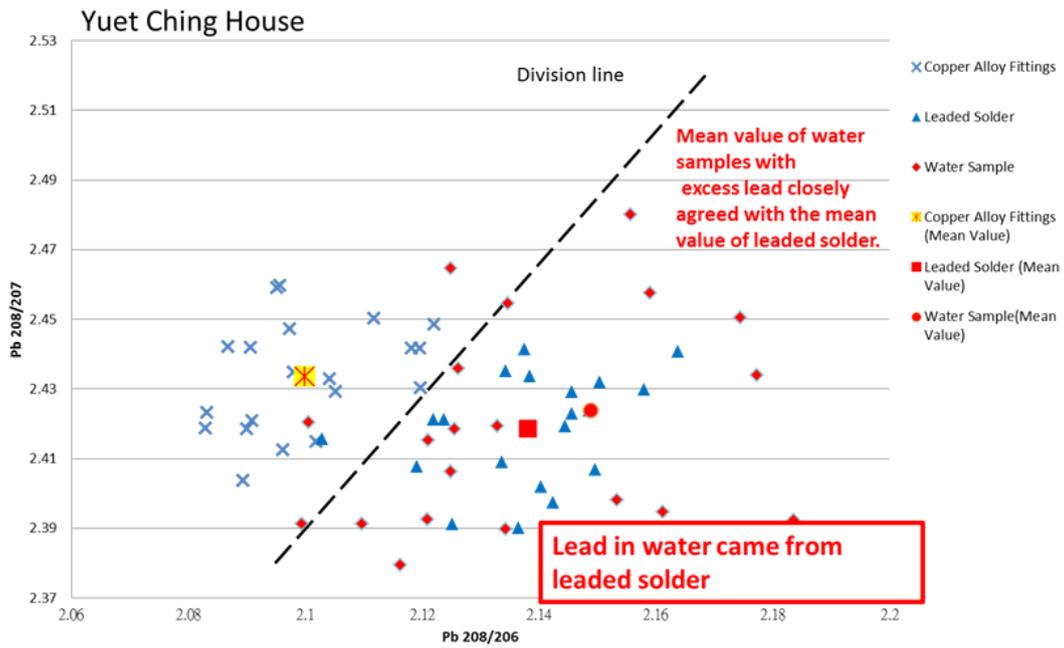
Figure 2.10 Isotopic analysis for the water supply chain in Yuet Ching House of KCE

- 2.9.6 Results of the isotopic analysis for the three water supply chains are shown in **Figures 2.9-2.11**. LDA of the lead isotopic ratios of the copper alloy valves and the leaded solder joints showed that they were two separate clusters at 95% confidence level and were significantly different from each other in all three water supply chains.
- 2.9.7 Further analysis of the isotopic ratios of the lead in the water samples showed that their mean values closely agreed with those of the leaded solder joints at 95% confidence level. It was therefore deduced that the lead in drinking water mainly came from the leaded solder joints.

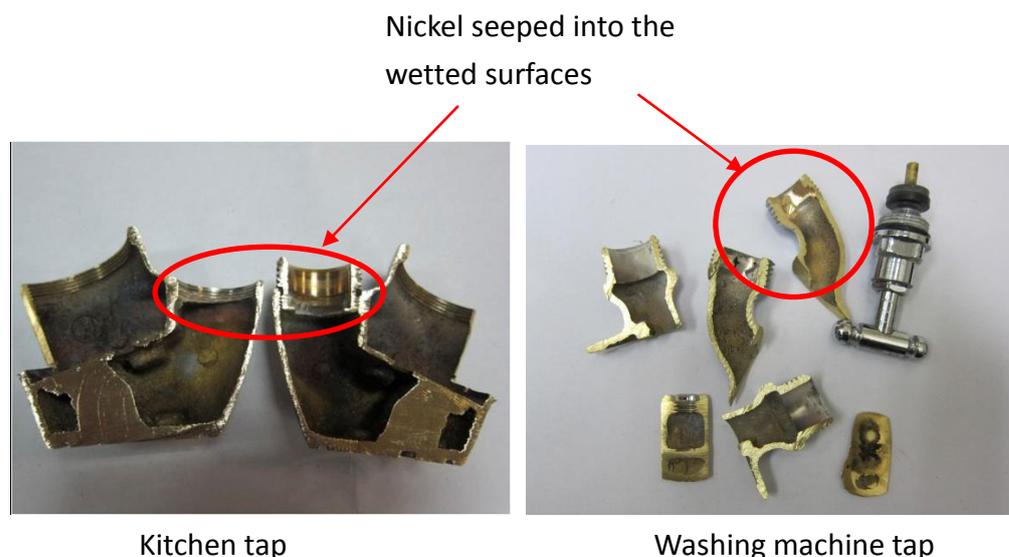
Figure 3.1 Cross-section of taps

3.3.1 The leaching test results for chromium, cadmium and nickel from the various components of pipes and fittings in the three water supply chains in KCE and KLE2 are shown in **Annexes 2.3(a)-(c)**. Based on the leaching test results, the amounts of chromium and cadmium leached from the various components were low. However, there was significant leaching of nickel from some taps in KCE, e.g. the highest leached amount of nickel after standing for 24 hours was 102.0 μ g or 1,569 μ g/L in one washing machine tap. Elemental analysis on the cross section of these taps showed that nickel had seeped into the wetted surfaces of the taps during electroplating (**Figure 3.1**). Nevertheless, as the taps hold very small amounts of water (less than 150ml) under stagnant condition, the leached nickel should be flushed away within one to two seconds after turning on the taps.
