Re-construction of Catchwater

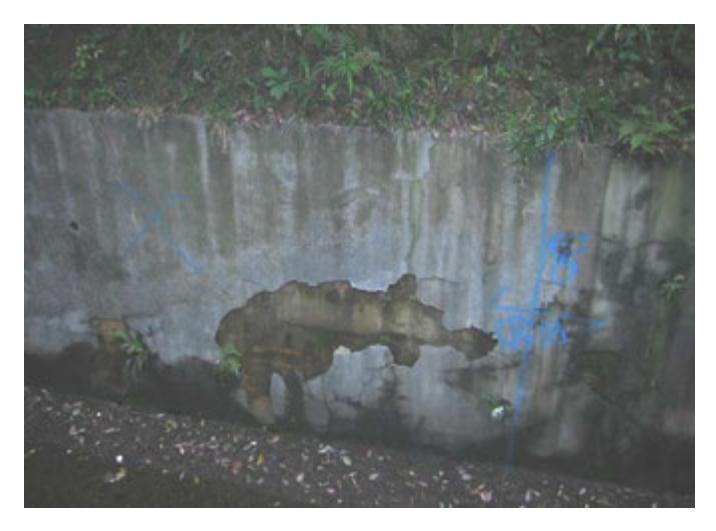
The 93 km of catchwater channels and 9 km of catchwater tunnels on Hong Kong Island, Lantau Island and in Tai Lam Chung have been in service for many decades ranging from 40 to more than 100 years. Many sections of the catchwater channels and tunnels are showing signs of ageing. The deteriorating condition of the catchwater channels and tunnels may lead to leakage (Figure 1). Breaking of the catchwater channels during rainstorms may result in flooding and slope failures.

Figure 1 : Deteriorated condition of existing catchwater channel

To ensure the continued stability of the catchwater channels and tunnels, Water Supplies Department (WSD) has commissioned projects to carry out repair and reconstruction works, as appropriate, for the defective sections of the catchwater channels and tunnels on Hong Kong Island, Lantau Island and in Tai Lam Chung. The projects also upgrade some priority slopes adjoining the catchwater channels in conjunction with the reconstruction and repair of catchwater channels.

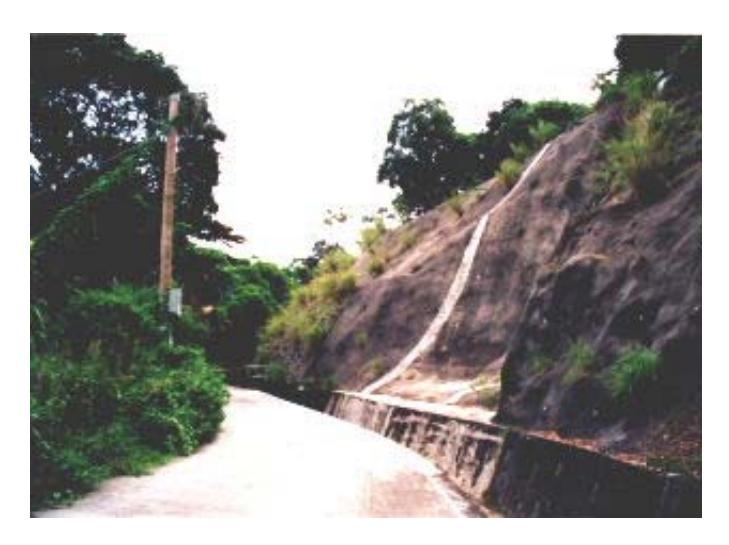
Moreover, many slopes formed along both sides of the catchwater channels are not up to current geotechnical standards. Some of these substandard slopes (Figure 2) could pose risk to lives, roads and developments nearby.

Figure 2 : Substandard slope

The methods of upgrading works for the cut slopes include soil nailing, provision of raking drains and surface drainage channel. These upgrading works, as compared to slope re-profiling, could minimize the volume of spoil for disposal, disturbance to vegetations and felling of trees beyond the crest of the slope.

The methods of upgrading works for the fill slopes include replacement and re-compaction of the existing fill material, thickening of the existing masonry wall, construction of concrete toe wall, soil nailing, provision of raking drains and surface drainage channel. Careful consideration has been given to the extent of replacement and re-compaction zones of existing fill with a view to maximize tree preservation. The stabilizing effect of the tree roots has been considered in the geotechnical design for areas with large number of trees and it results in avoiding felling of large number of trees.

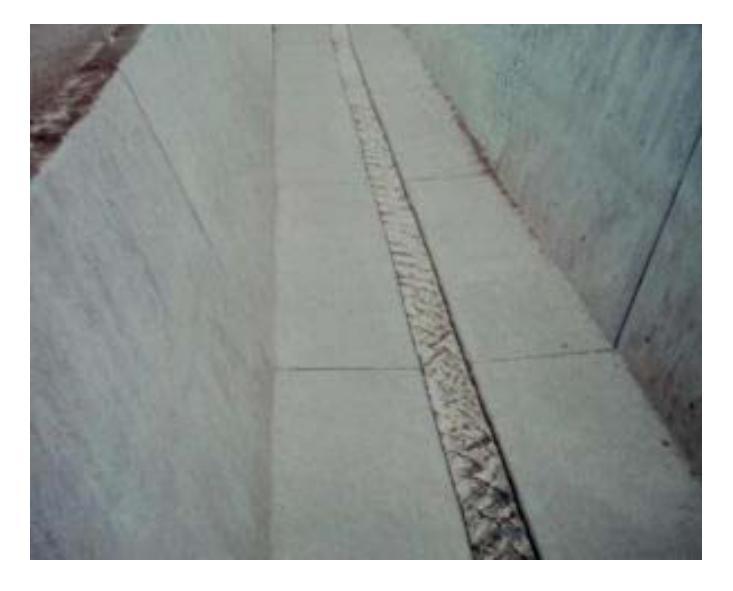
The general view of the catchwater channel after repair is depicted below (Figure 3).

Figure 3 : Catchwater channel after repair

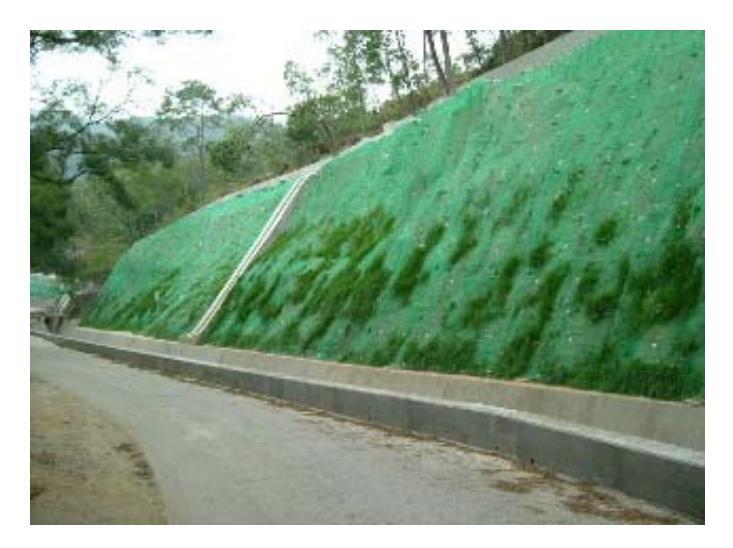
To improve the visual impact and to blend with the natural environment after slope upgrading works, the fill slope surface is to be landscaped by treatment of grass hydroseeding and planting of shrub and tree seedlings. For cut slopes, hydroseeding and multch matting system with shrub seedling planting are to be provided (Figure 4).

Figure 4 : Upgraded priority slope with landscape
