**Feasibility Study on Use of  
Supplementary Cementitious  
Materials to Mitigate Alkali-silica  
Reaction in Concrete Made with  
Volcanic Aggregates**

**H.D. Wong and Wallace S.M. Tam**

This Technical Note presents the findings of the study based on a two-year laboratory investigation on the length measurements of the expansion of the concrete prisms.

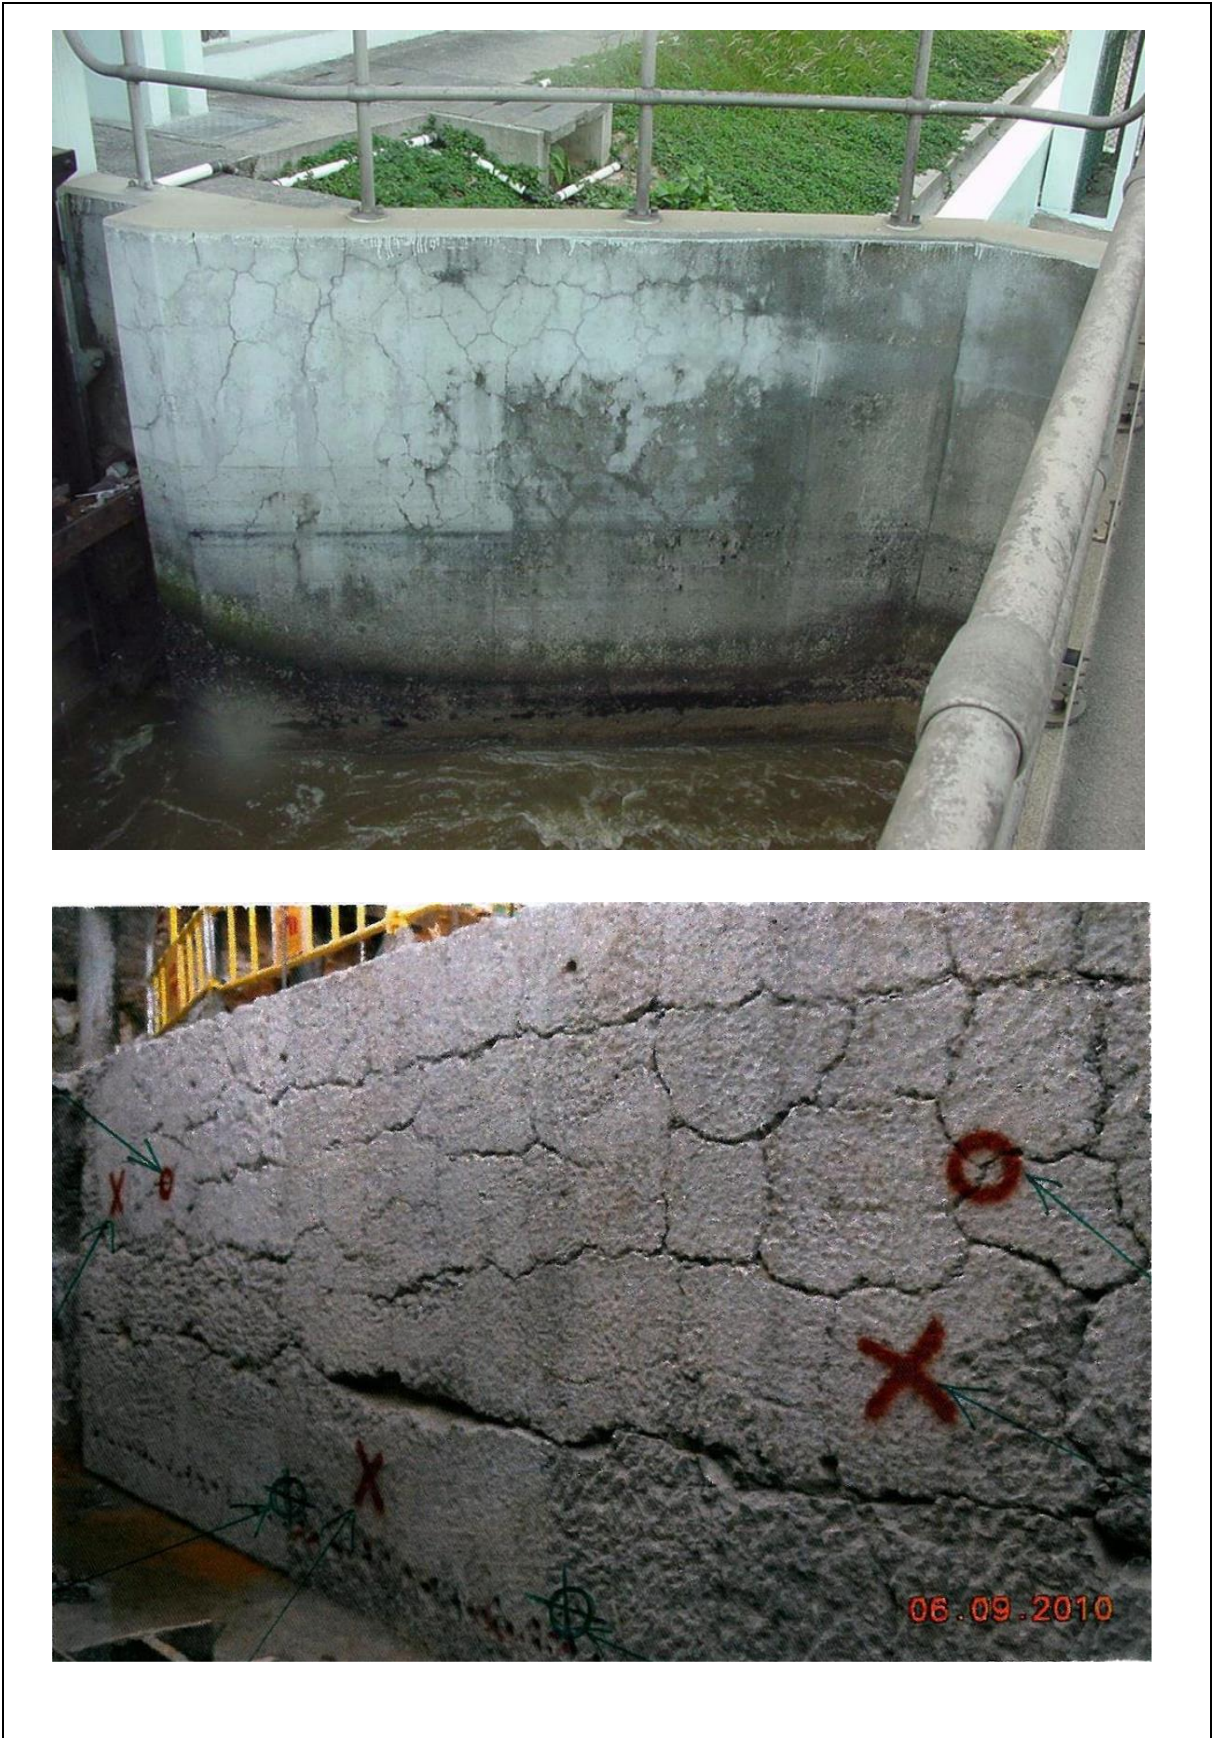
Figure 2.1 Typical Pattern of ASR Cracks

The visual features of structures affected by ASR are typically map patterned cracks, cracks parallel to the main reinforcements, pop-outs or swelling of concrete, etc. Some typical pattern of the cracks caused by ASR are shown in Figure 2.1. It is however important to note that it will be very difficult to cease the ASR once started.

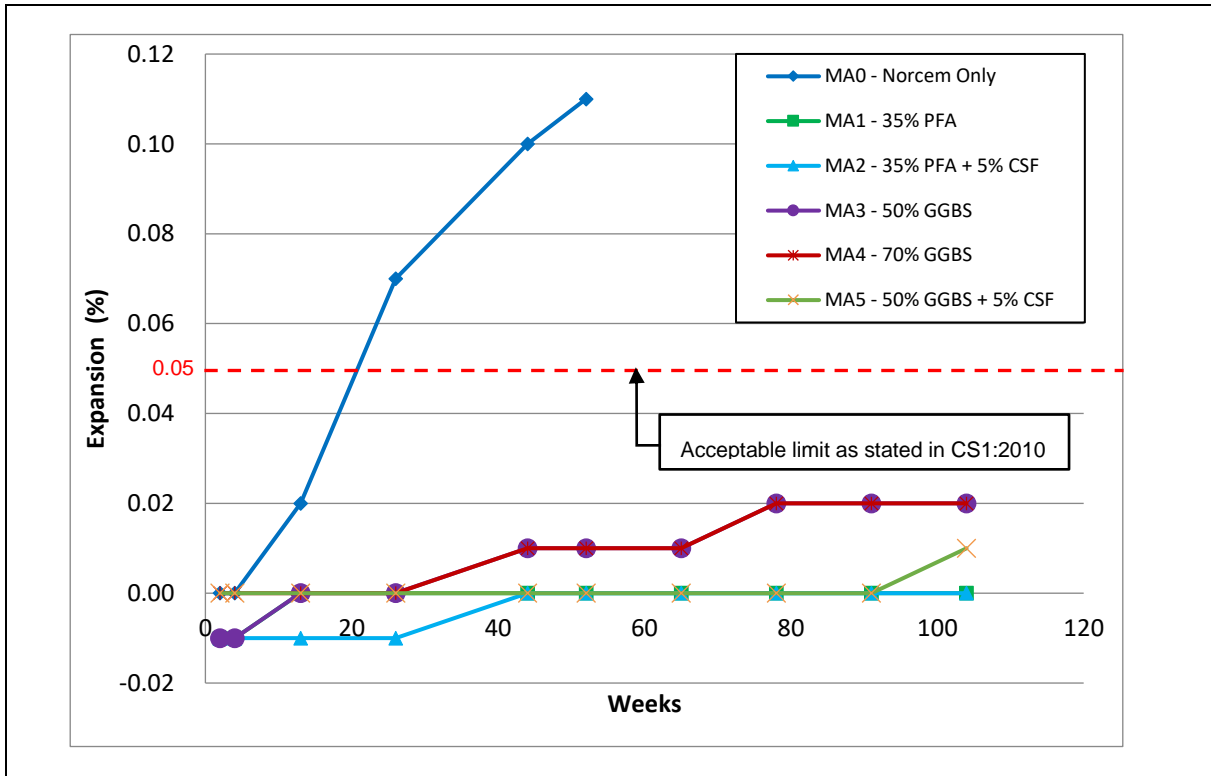
Figure 5.2 Average Expansion of Concrete Prisms (Anderson Road Quarry)

The test results of expansion and weight changes of the concrete prism test are shown in Tables 5.5 to 5.16 and Figures 5.2 to 5.5.

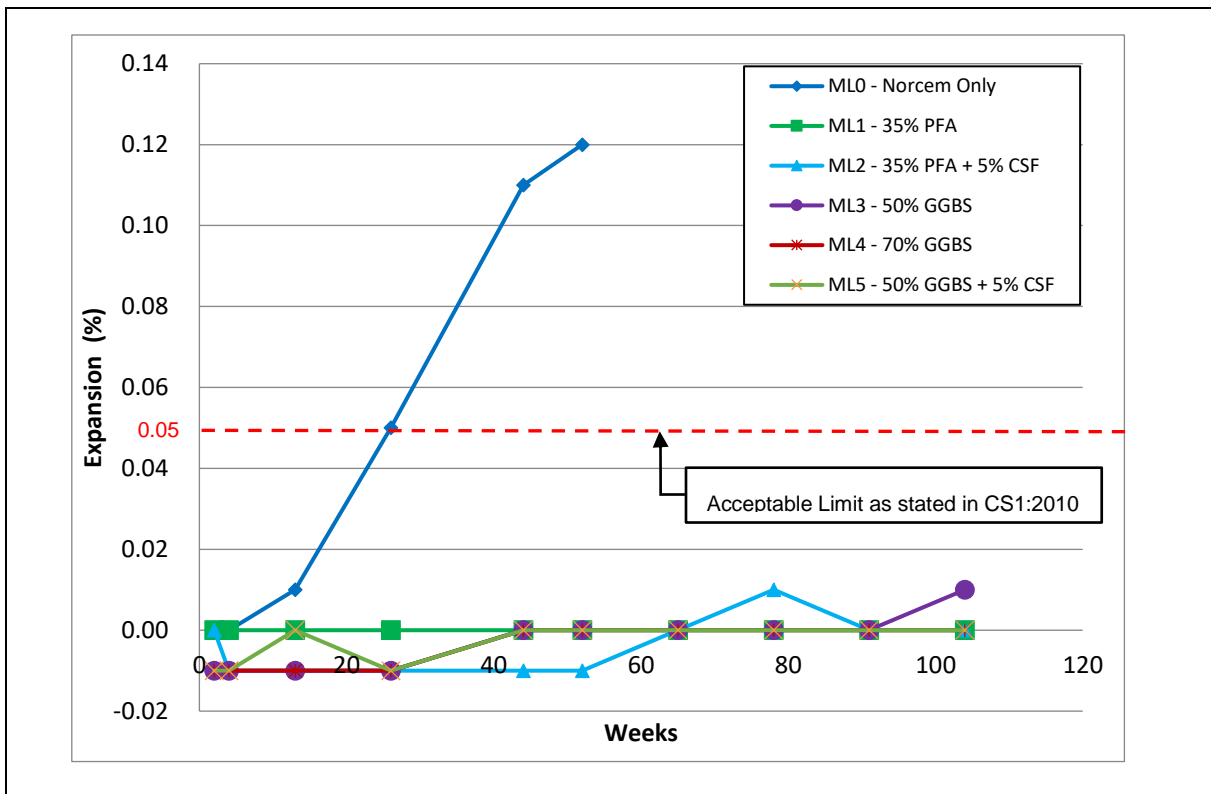
Figure 5.3 Average Expansion of Concrete Prisms (Lam Tei Quarry)

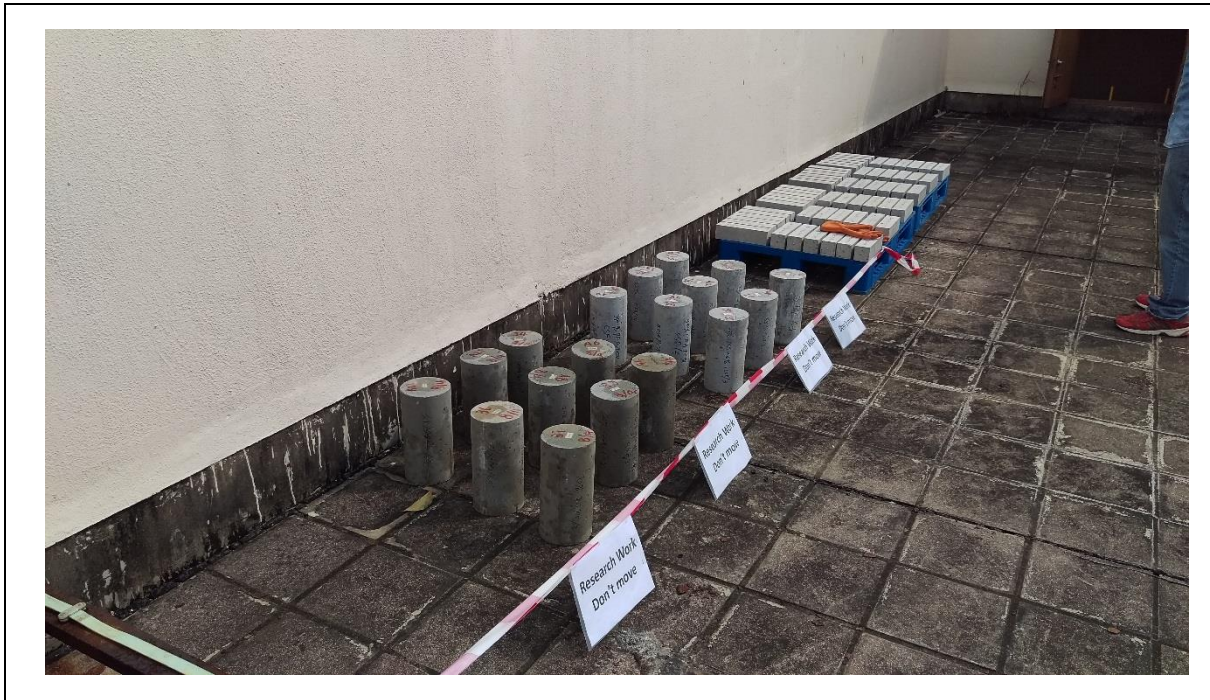
**Figure 7.1 Cylinder Specimens Stored on the Rooftop of PWCL Building**

A 12 mm diameter steel reinforcing bar is installed in the centre of each cylinder specimen. The cylinder specimens are stored in the open area of the rooftop of PWCL

Building as shown in Figure 7.1.

- (1) Visual inspections for any signs of cracks;
- (2) Height measurement at  $0^\circ$ ,  $90^\circ$ ,  $180^\circ$  and  $270^\circ$ ;
- (3) Diameter measurement at  $0^\circ$ ,  $90^\circ$  1/3 height and  $0^\circ$ ,  $90^\circ$  2/3 height; and
- (4) Taking record photos.
