Re-construction of Catchwater

Introduction

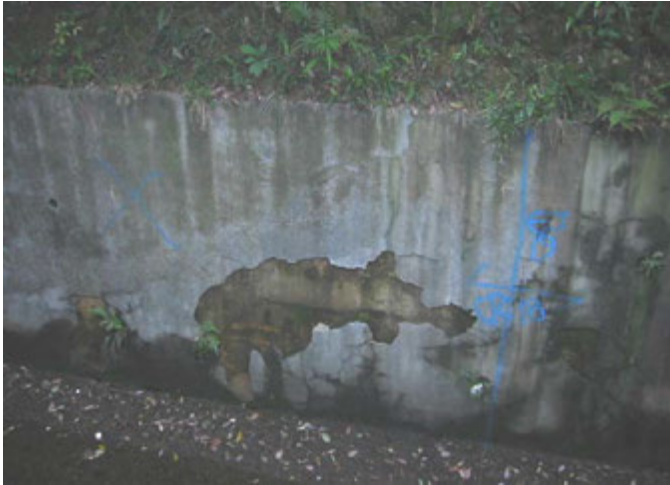
The 93 km of catchwater channels and 9 km of catchwater tunnels on Hong Kong Island, Lantau Island and in Tai Lam Chung have been in service for many decades ranging from 40 to more than 100 years. Many sections of the catchwater channels and tunnels are showing signs of ageing. The deteriorating condition of the catchwater channels and tunnels may lead to leakage (Figure 1). Breaking of the catchwater channels during rainstorms may result in flooding and slope failures.

Figure 1 : Deteriorated condition of existing catchwater channel

Repair of the catchwater channels is to be carried out wherever practical. For those sections with deteriorated condition beyond repair, reconstruction is to be carried out. These sections are typically those with severe or multiple cracks on structures and significantly dislocated joints between structures of the catchwater channels. The defective section of the catchwater channel is completely demolished and reconstructed with reinforced concrete structure of the same profile of the existing catchwater channel.

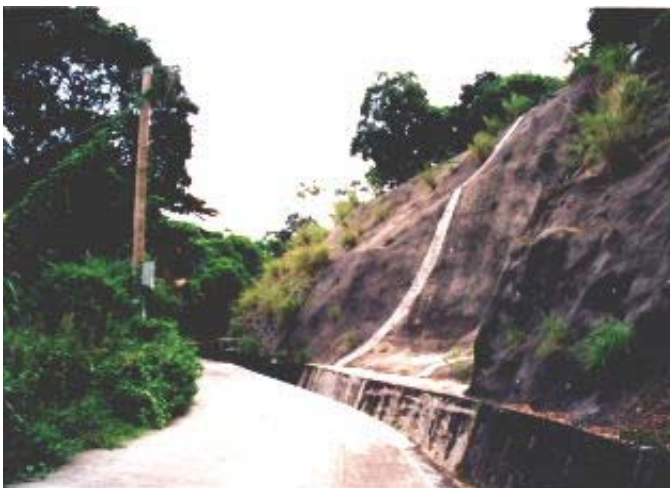
Moreover, many slopes formed along both sides of the catchwater channels are not up to current geotechnical standards. Some of these substandard slopes (Figure 2) could pose risk to lives, roads and developments nearby.

Figure 2 : Substandard slope

The methods of upgrading works for the cut slopes include soil nailing, provision of raking drains and surface drainage channel. These upgrading works, as compared to slope re-profiling, could minimize the volume of spoil for disposal, disturbance to vegetations and felling of trees beyond the crest of the slope.

The methods of upgrading works for the fill slopes include replacement and re-compaction of the existing fill material, thickening of the existing masonry wall, construction of concrete toe wall, soil nailing, provision of raking drains and surface drainage channel. Careful consideration has been given to the extent of replacement and re-compaction zones of existing fill with a view to maximize tree preservation. The stabilizing effect of the tree roots has been considered in the geotechnical design for areas with large number of trees and it results in avoiding felling of large number of trees.

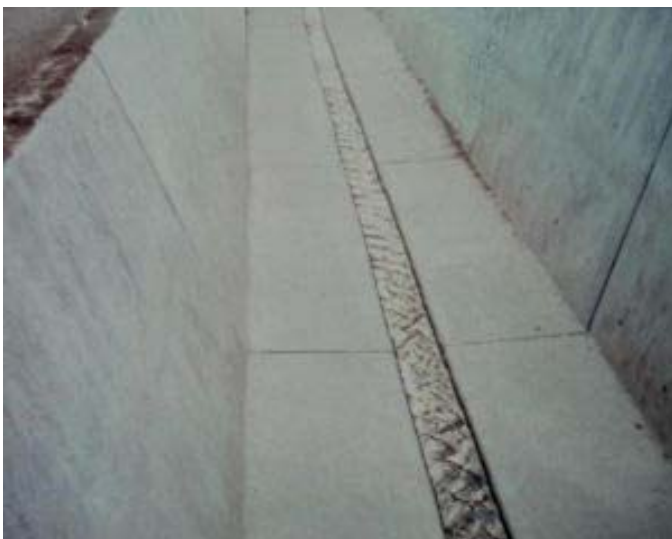
The general view of the catchwater channel after repair is depicted below (Figure 3).

Figure 3 : Catchwater channel after repair

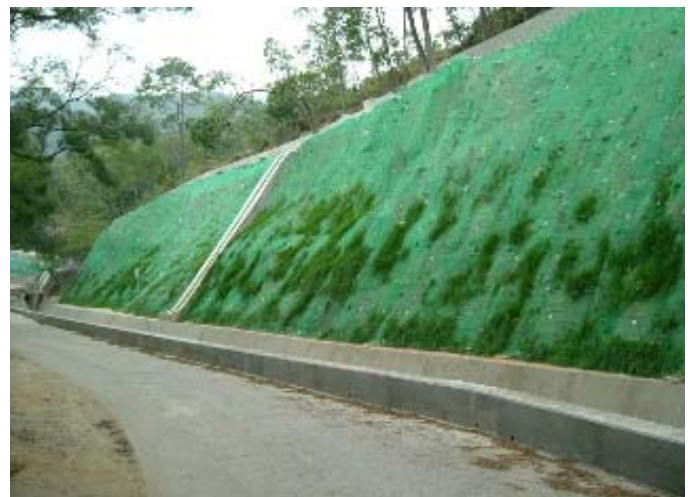
To improve the visual impact and to blend with the natural environment after slope upgrading works, the fill slope surface is to be landscaped by treatment of grass hydroseeding and planting of shrub and tree seedlings. For cut slopes, hydroseeding and mulch matting system with shrub seedling planting are to be provided (Figure 4).

Figure 4 : Upgraded priority slope with landscape
